# Drinking Water Chromium-6 (Cr6) Update

WESTCAS Annual Conference  
San Diego, California  
June 21, 2018

# Full-scale Demonstration

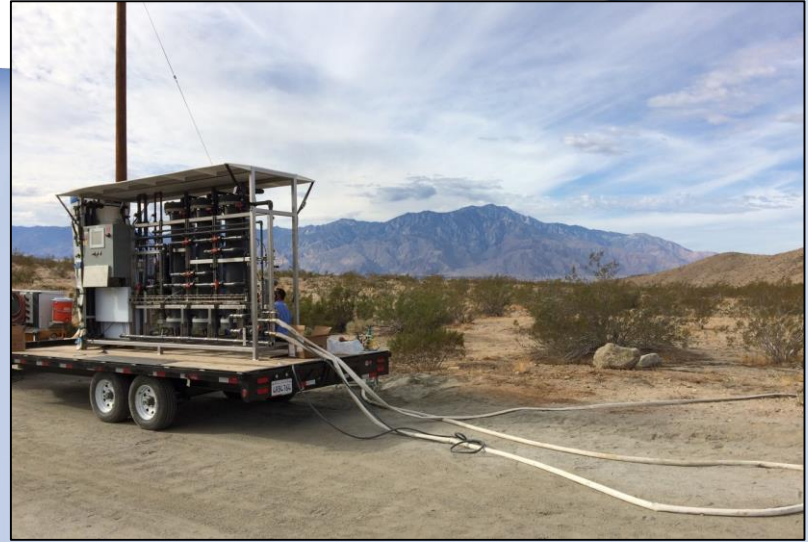
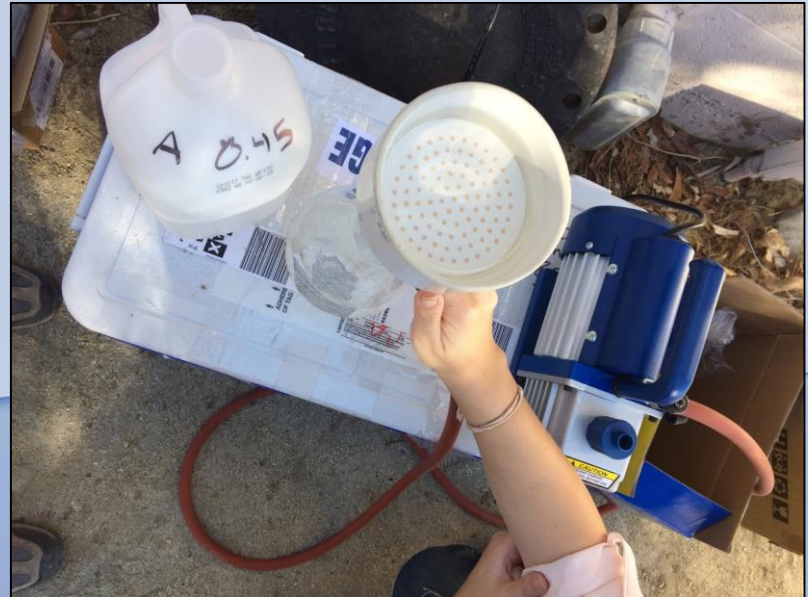
# Hydrant Flushing Test

- 10-minute flush performed at hydrant near MRT tank site
- Compared flush water conditions before & after  $\text{SnCl}_2$  demonstration
- Compared unfiltered and filtered flush water ( $0.35\text{-}1\text{ }\mu\text{m}$ )
- Tests included turbidity, total Sn, total Cr, Cr6

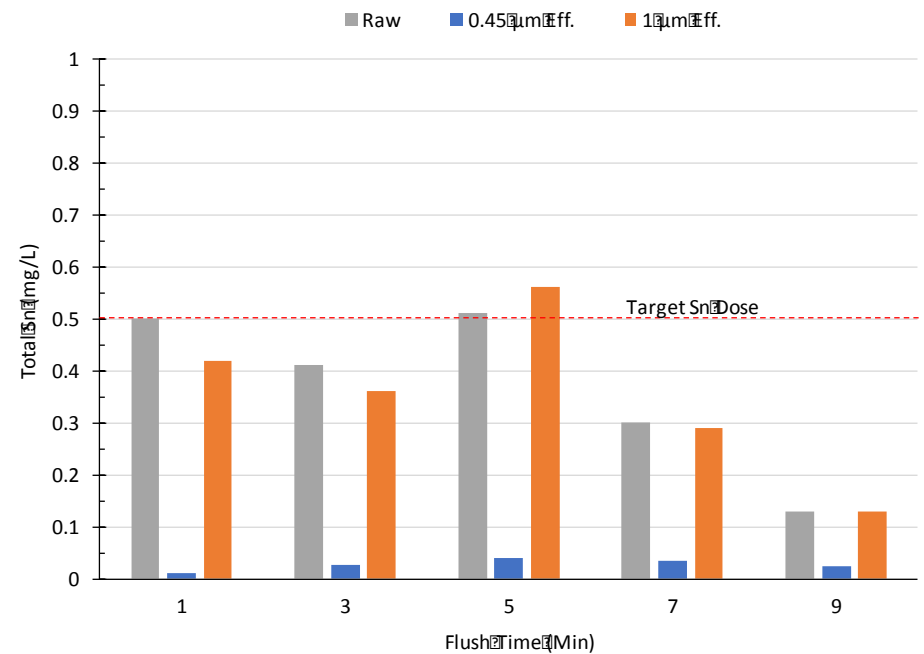
# Flushing Test Results - Sn

## With-Sn Flush

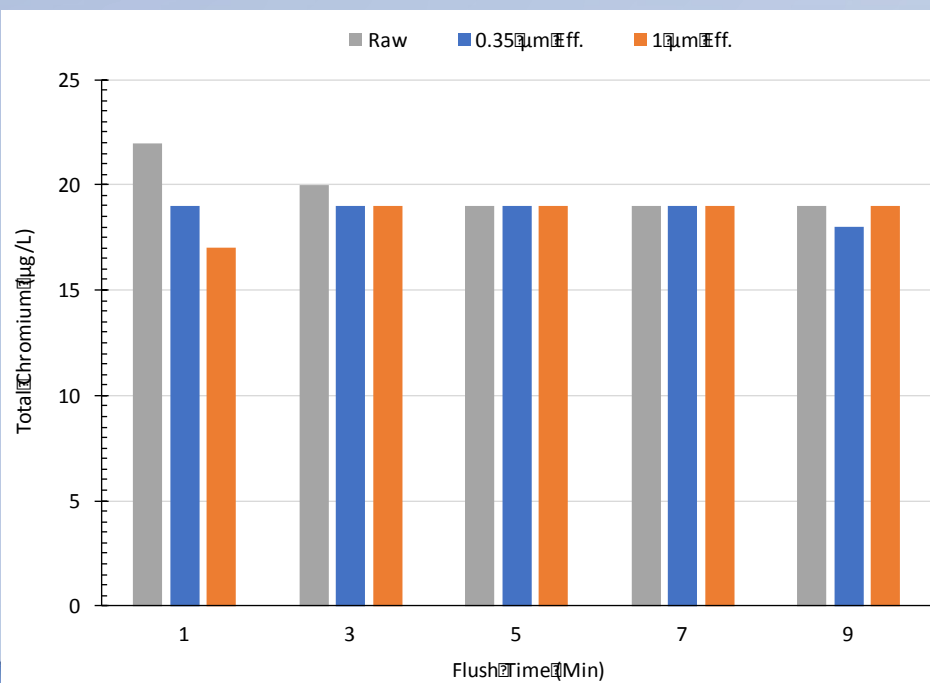
# Flushing Test Results – Total Cr

## Baseline Flush

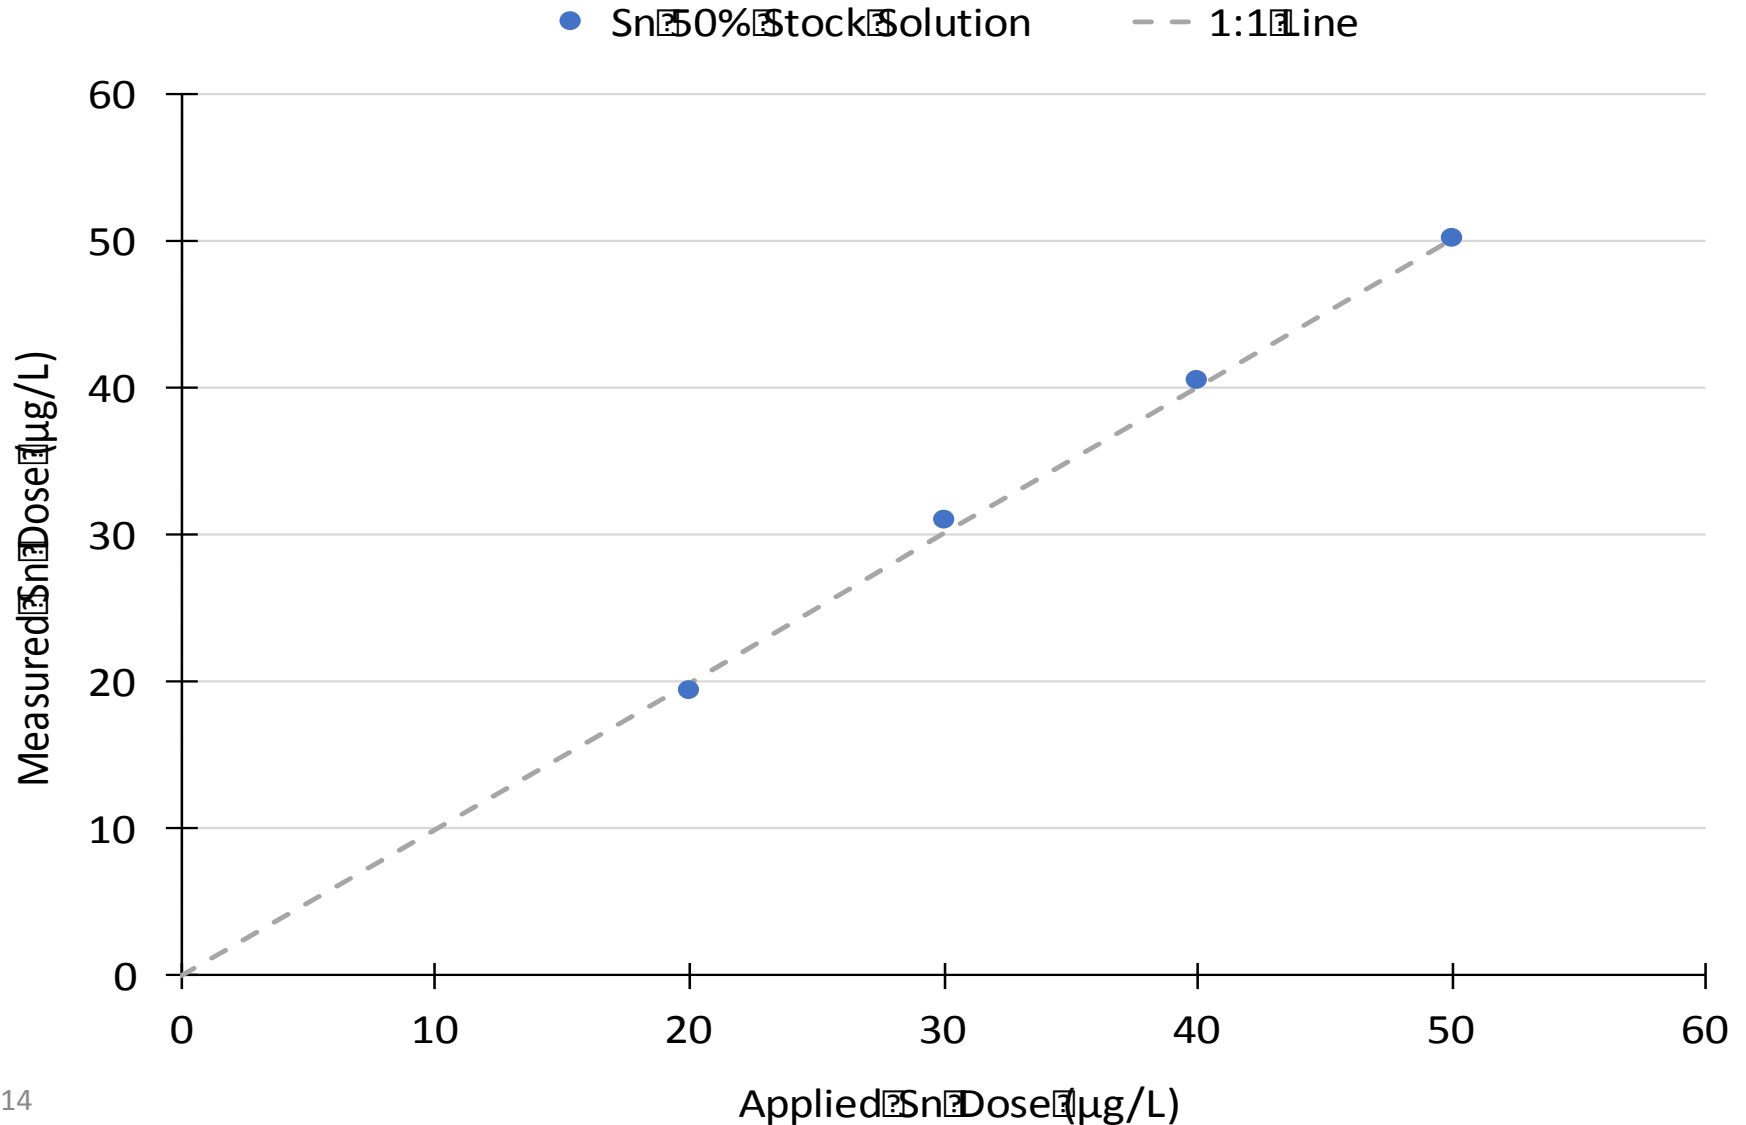
## March 2, 2018

# Stannous Stock Efficacy

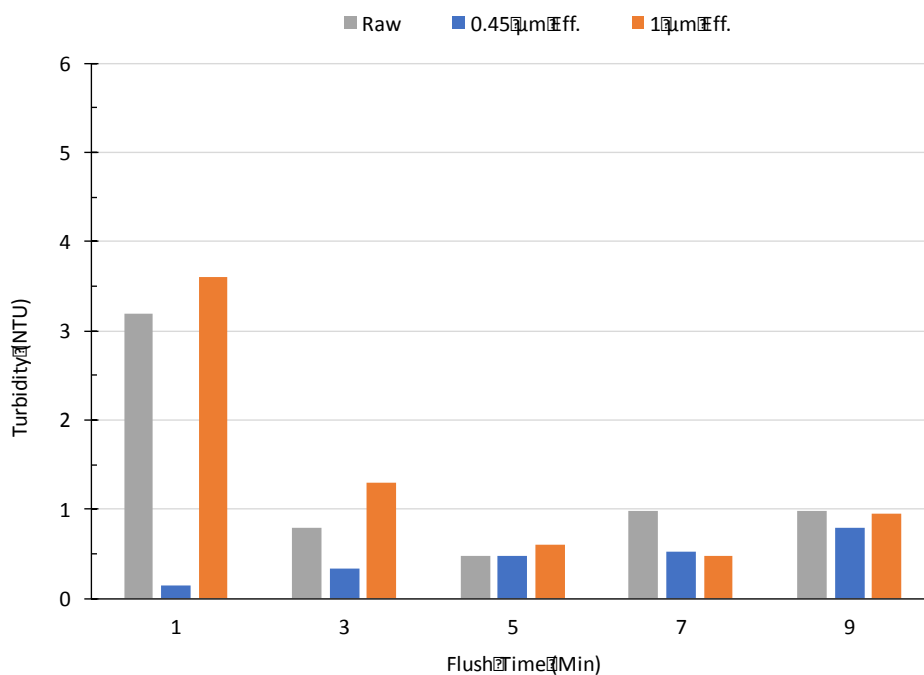
# Flushing Test Results - Turbidity

## With Sn Flush

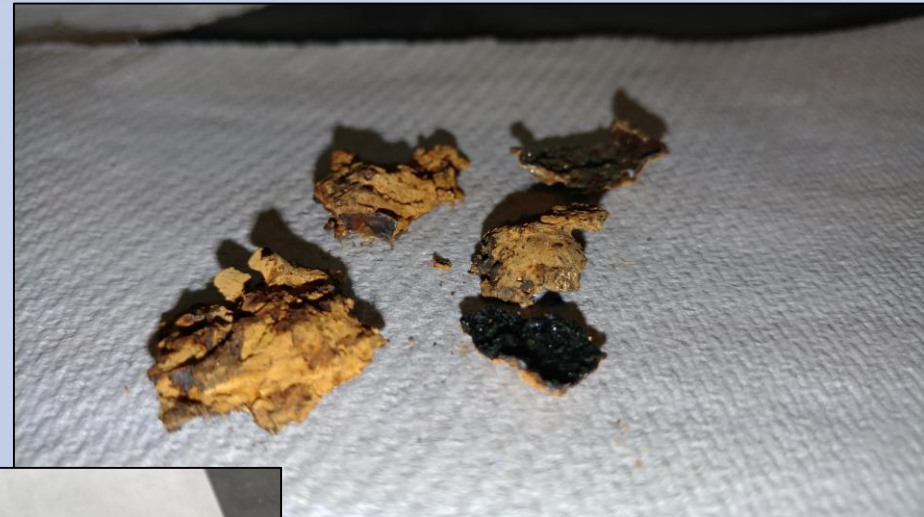
Outer layer pipe scales

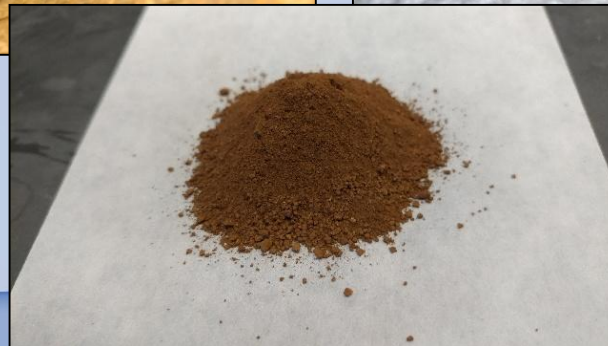
Prepared scale sample
