2011 Western Wildfires

Impact on Watersheds

Penny Luehring October, 2011

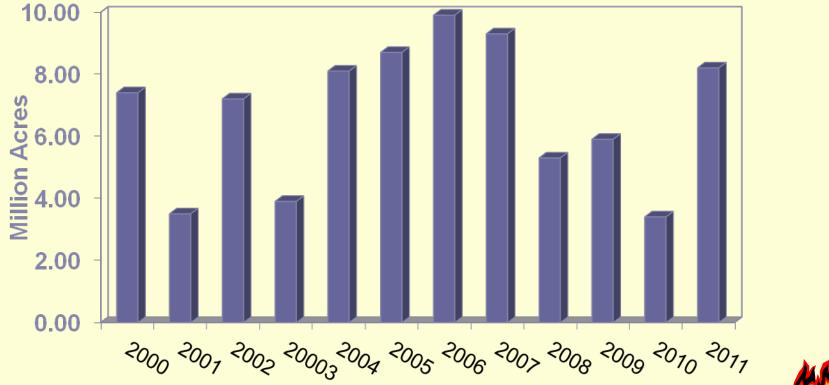
Acres Burned Annually in the U.S.

2000-2011

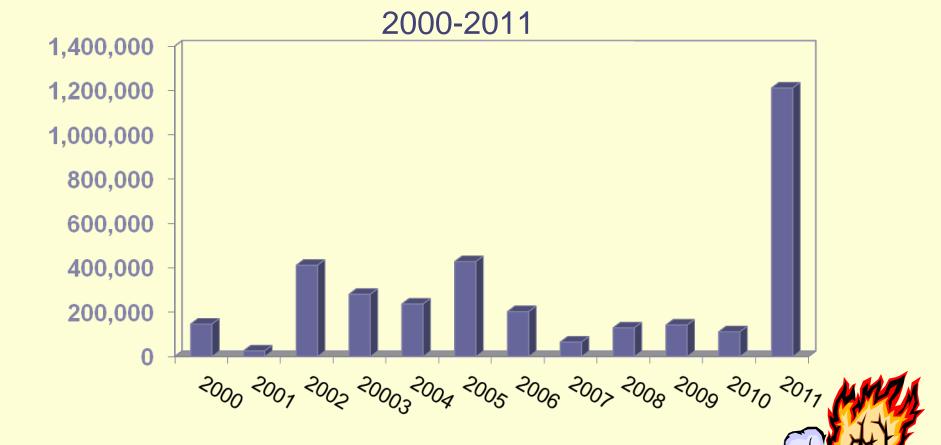
Acres Burned Annually in the Southwest

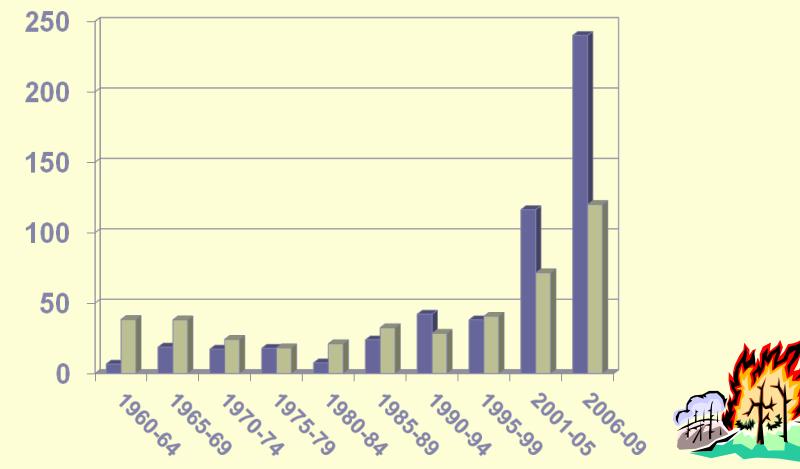
Average Fire Size Regionally and Nationally (acres)

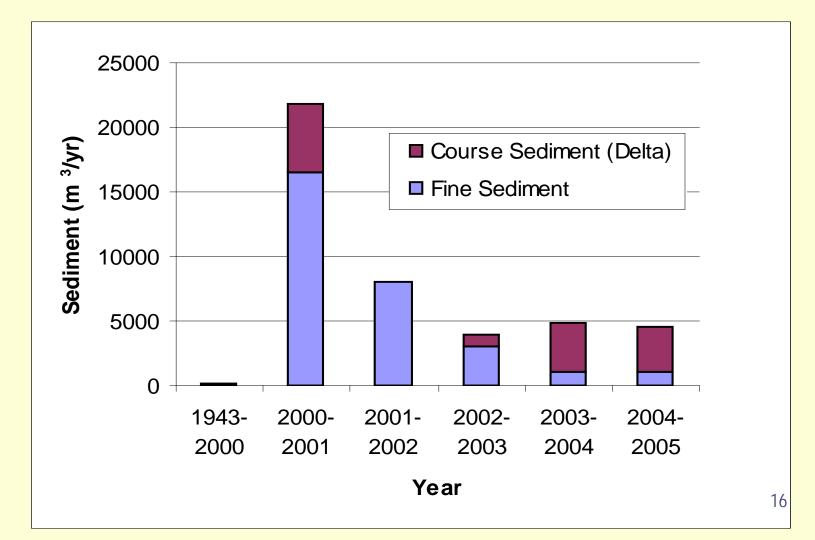
Sediment Yield, Los Alamos Canyon Cerro Grande Fire, 2000-2005

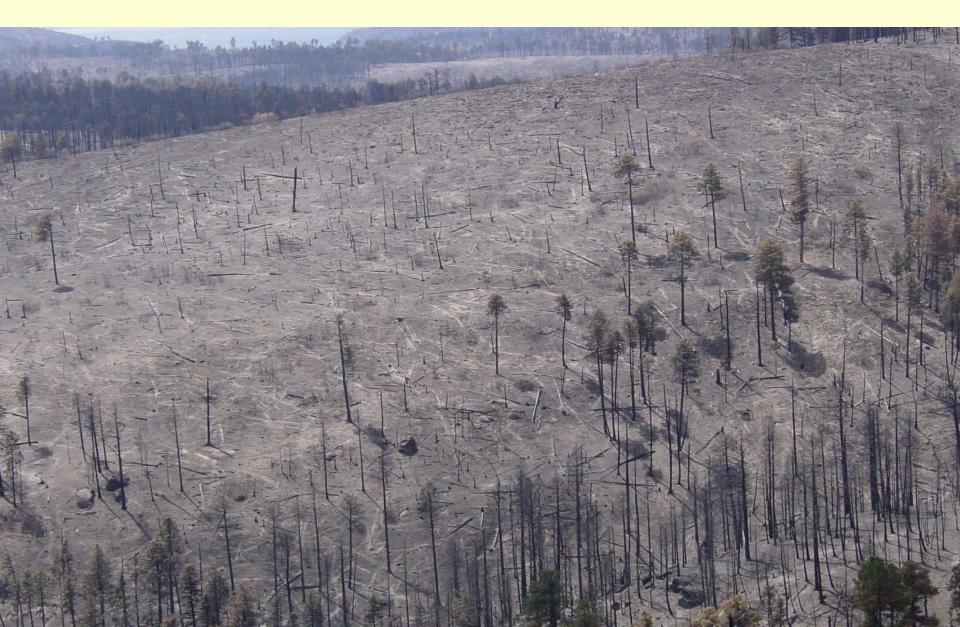
Large areas of high burn severity

Burn severity + steep slopes = high flood risk

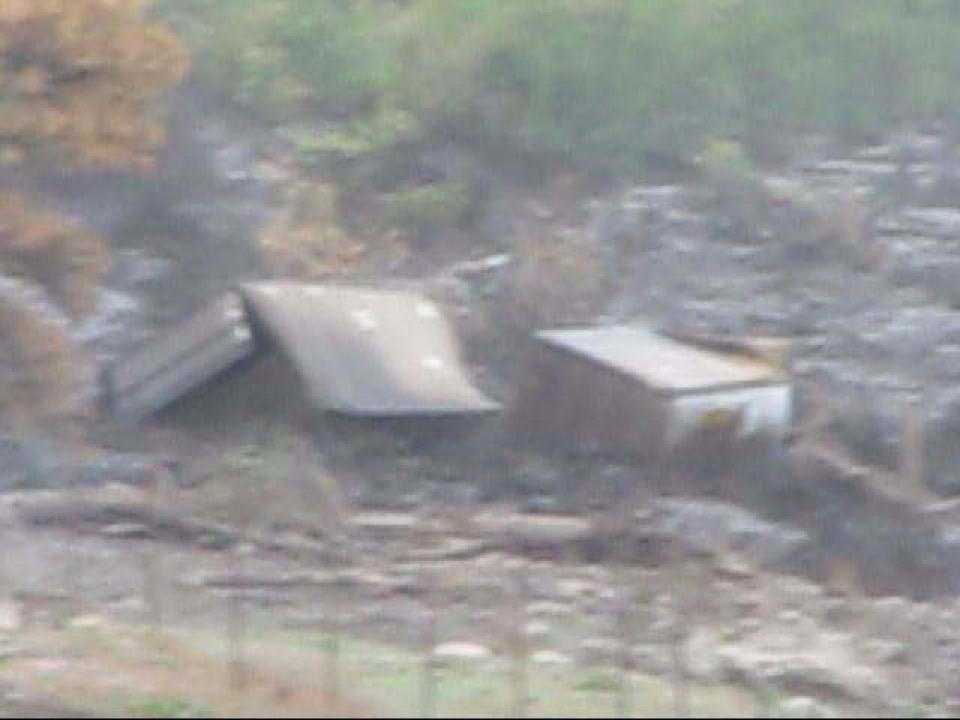
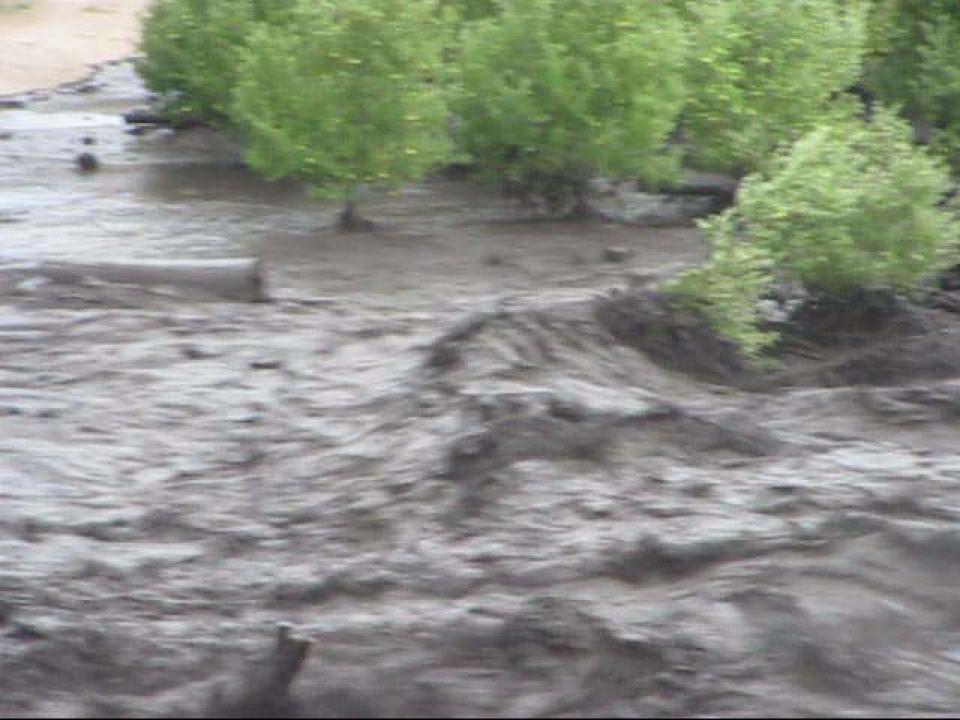
Cochiti Canyonbefore monsoons

Cochiti Canyonafter monsoons

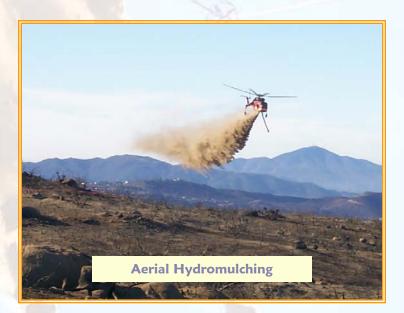
- Mulch Application
 - Mulch is used to provide immediate soil cover to reduce rain impact and soil erosion.
 - Mulch may be applied manually or mechanically.

Aerial Straw Mulch (Helimulch)

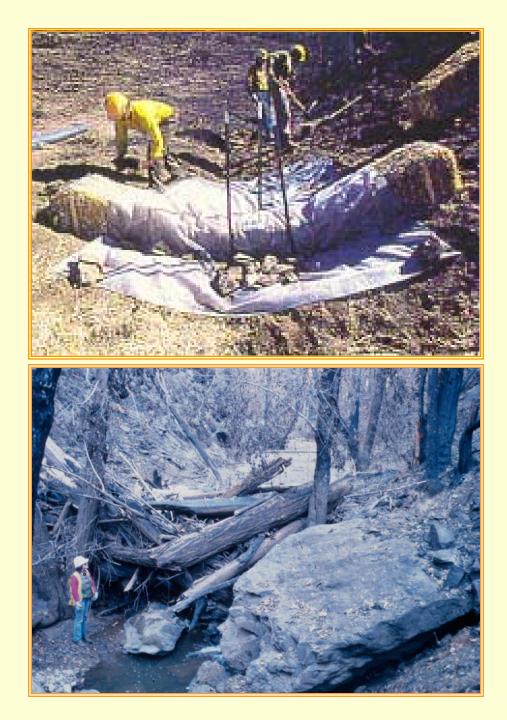
- In-stream Structures
 - Small straw or log dams
 - Rip-rap
- Debris Removal
 Clearing vegetative obstructions

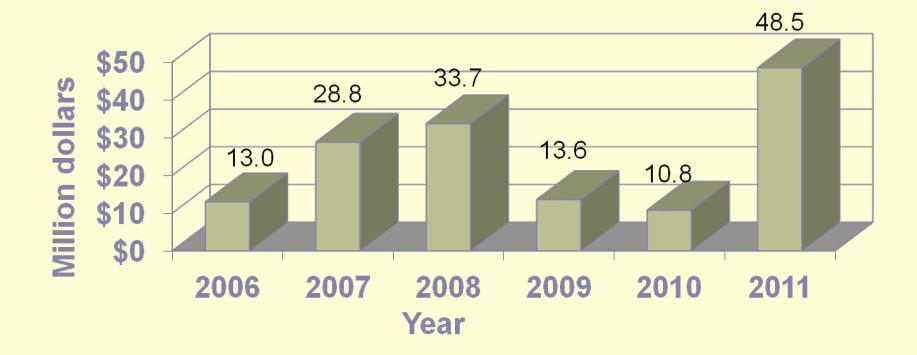
Emergency Stabilization Expenditures Forest Service
