Design, Operating and Maintaining Tempe Town Lake and its New Steel Dam

Craig M. Caggiano

Stewart S. Vaghti, P.E., CFM,

October 27, 2016

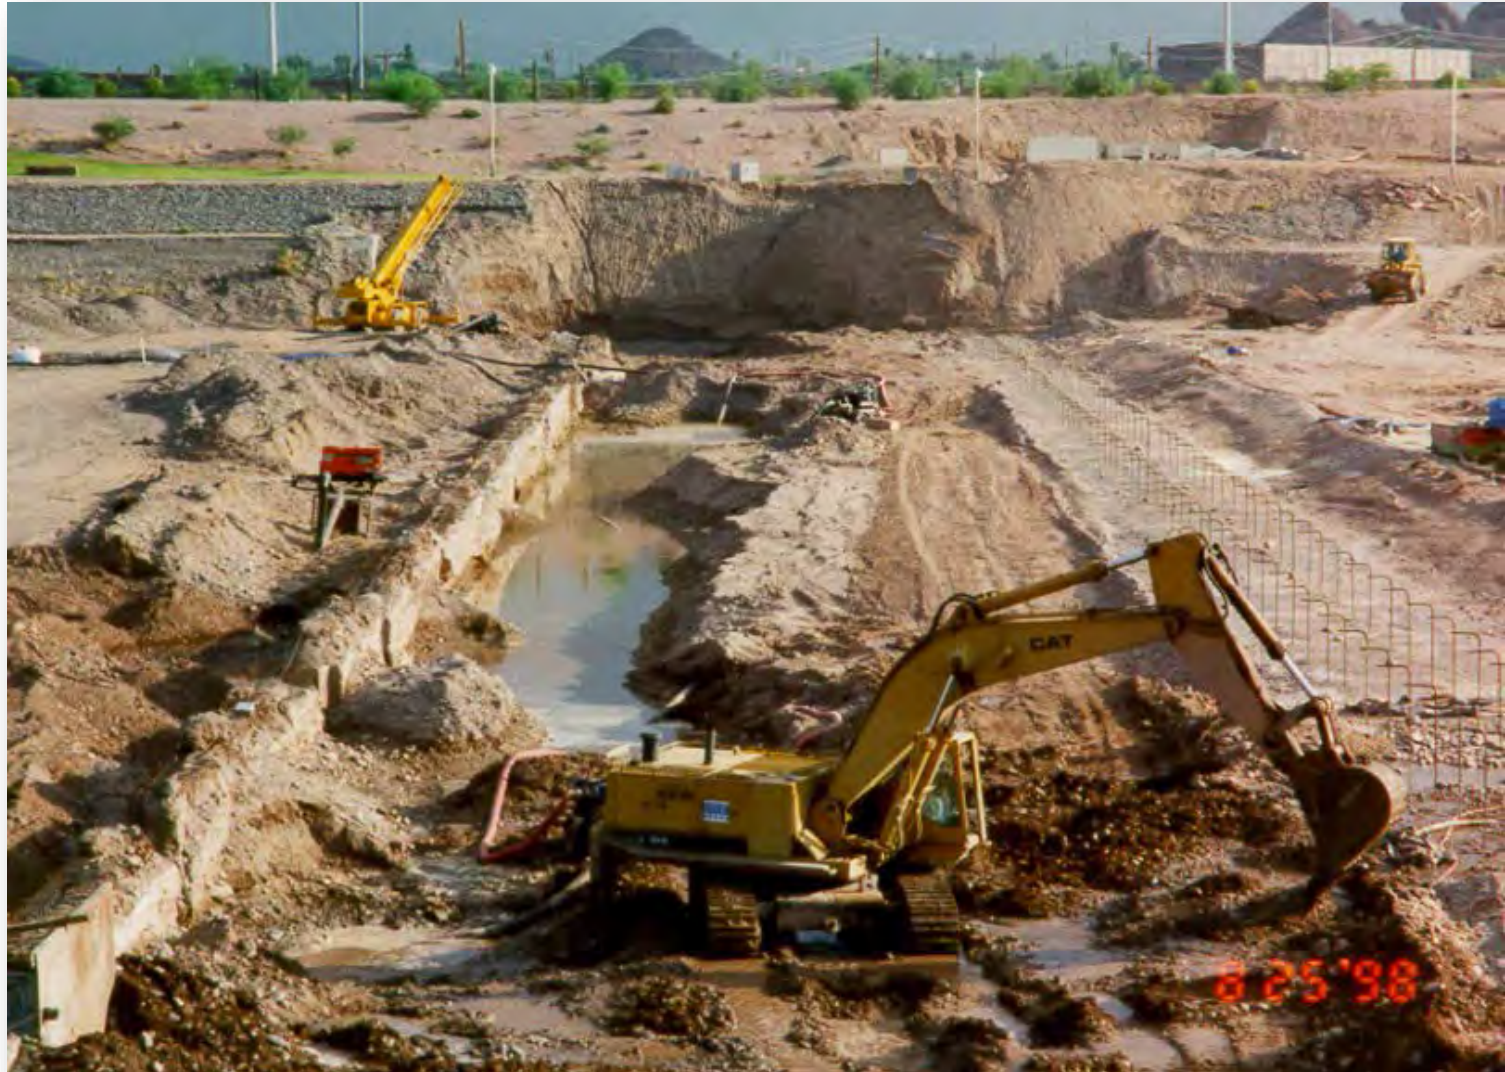
Original Dam

Construction Time: 1997 - 1999

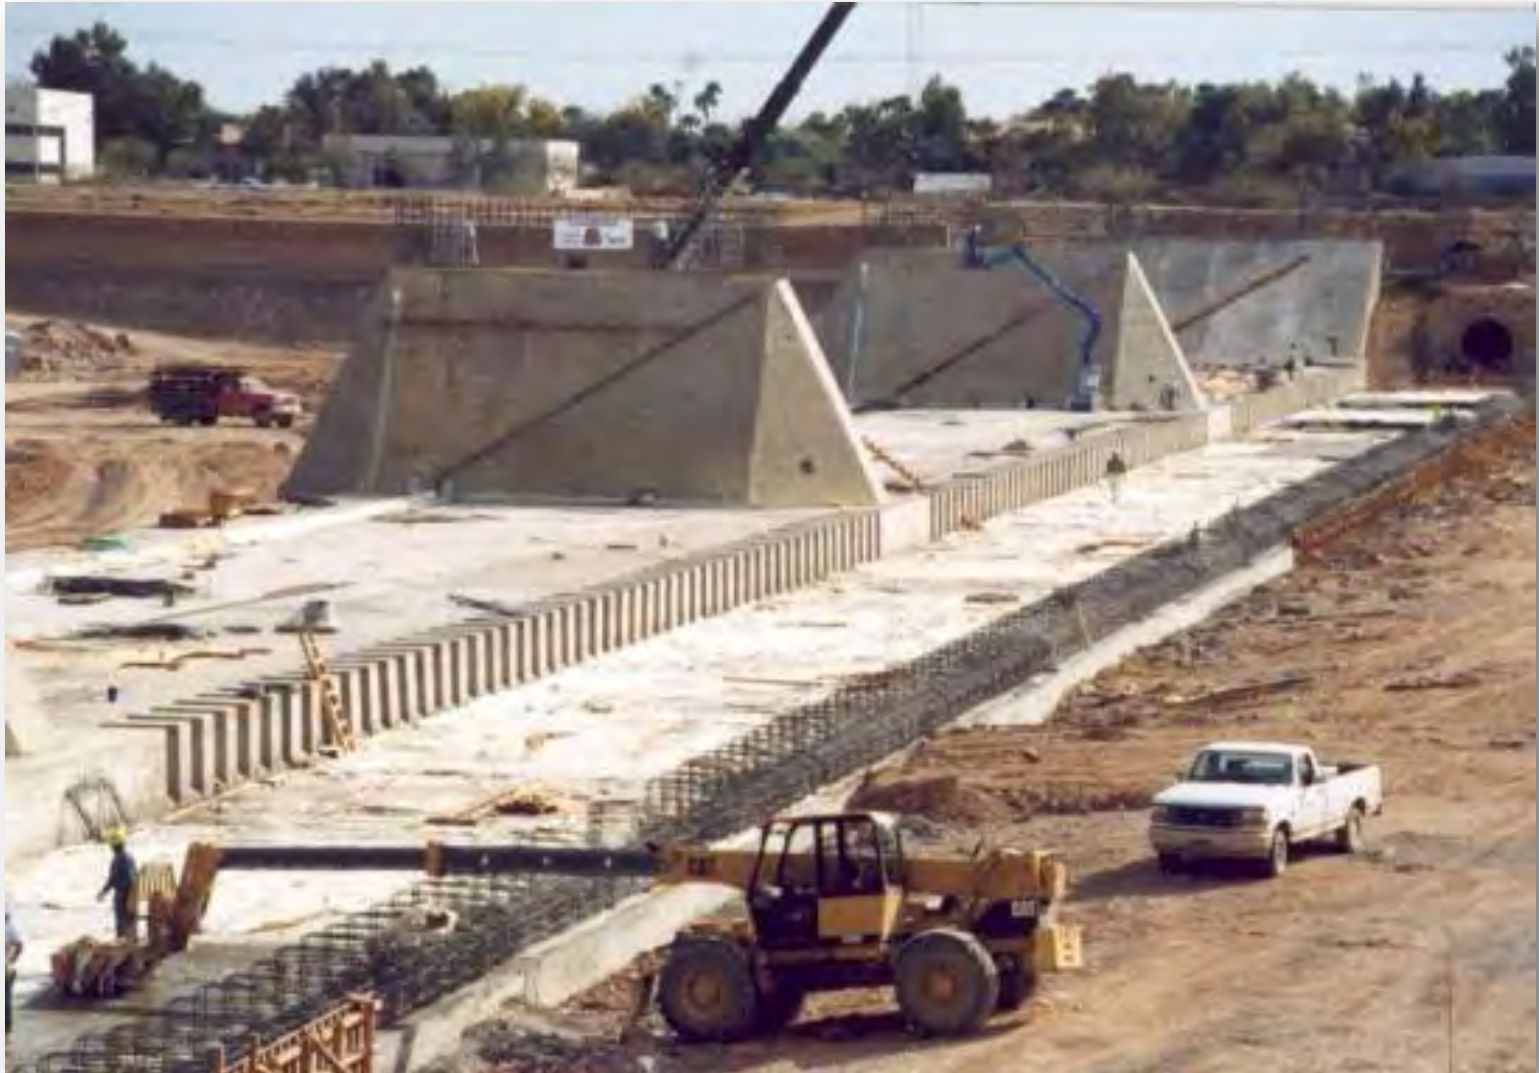
Original Dam

Construction Time: 1997 - 1999

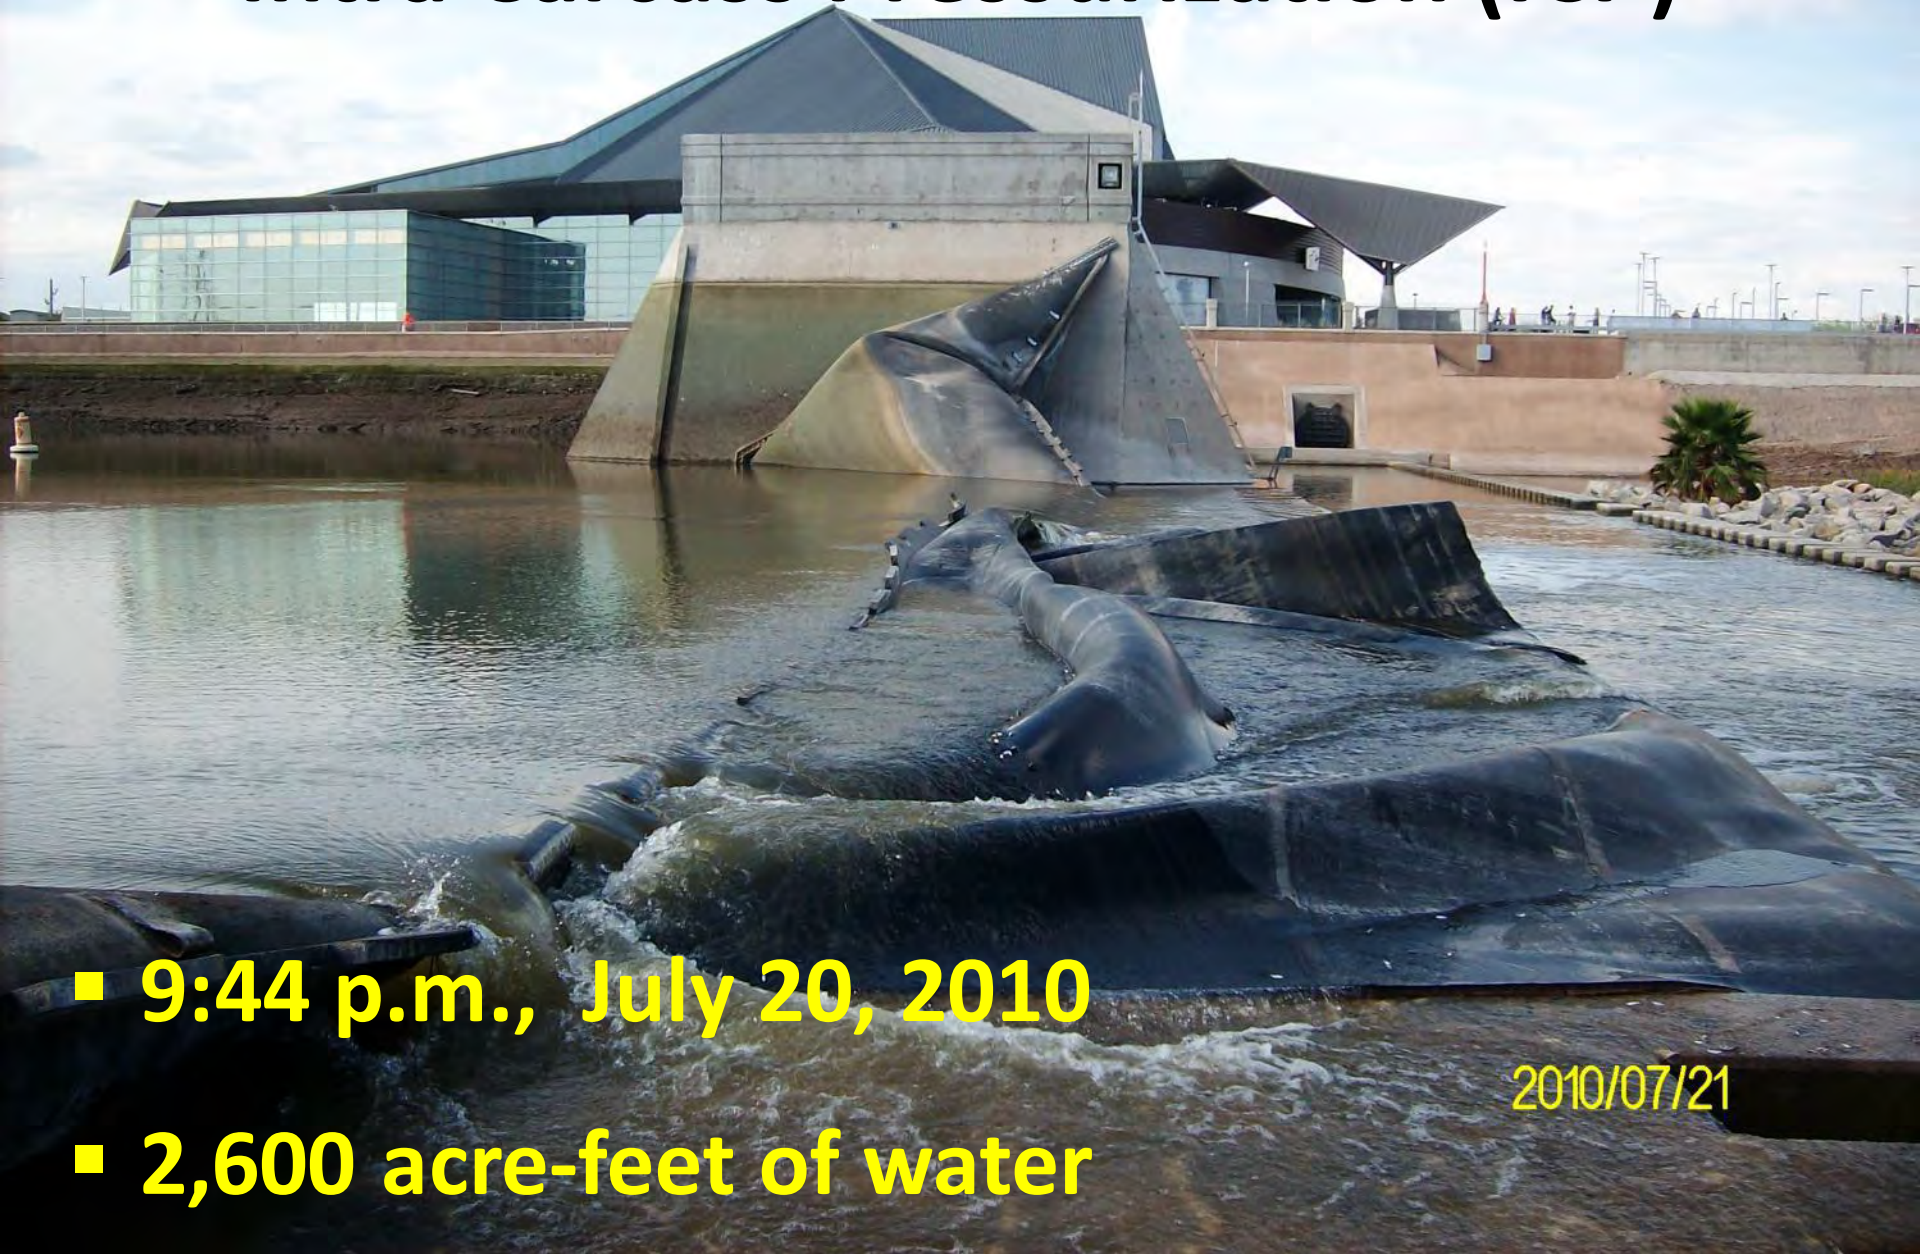
Intra Carcass Pressurization (ICP)

■ 9:44 p.m., July 20, 2010

■ 2,600 acre-feet of water

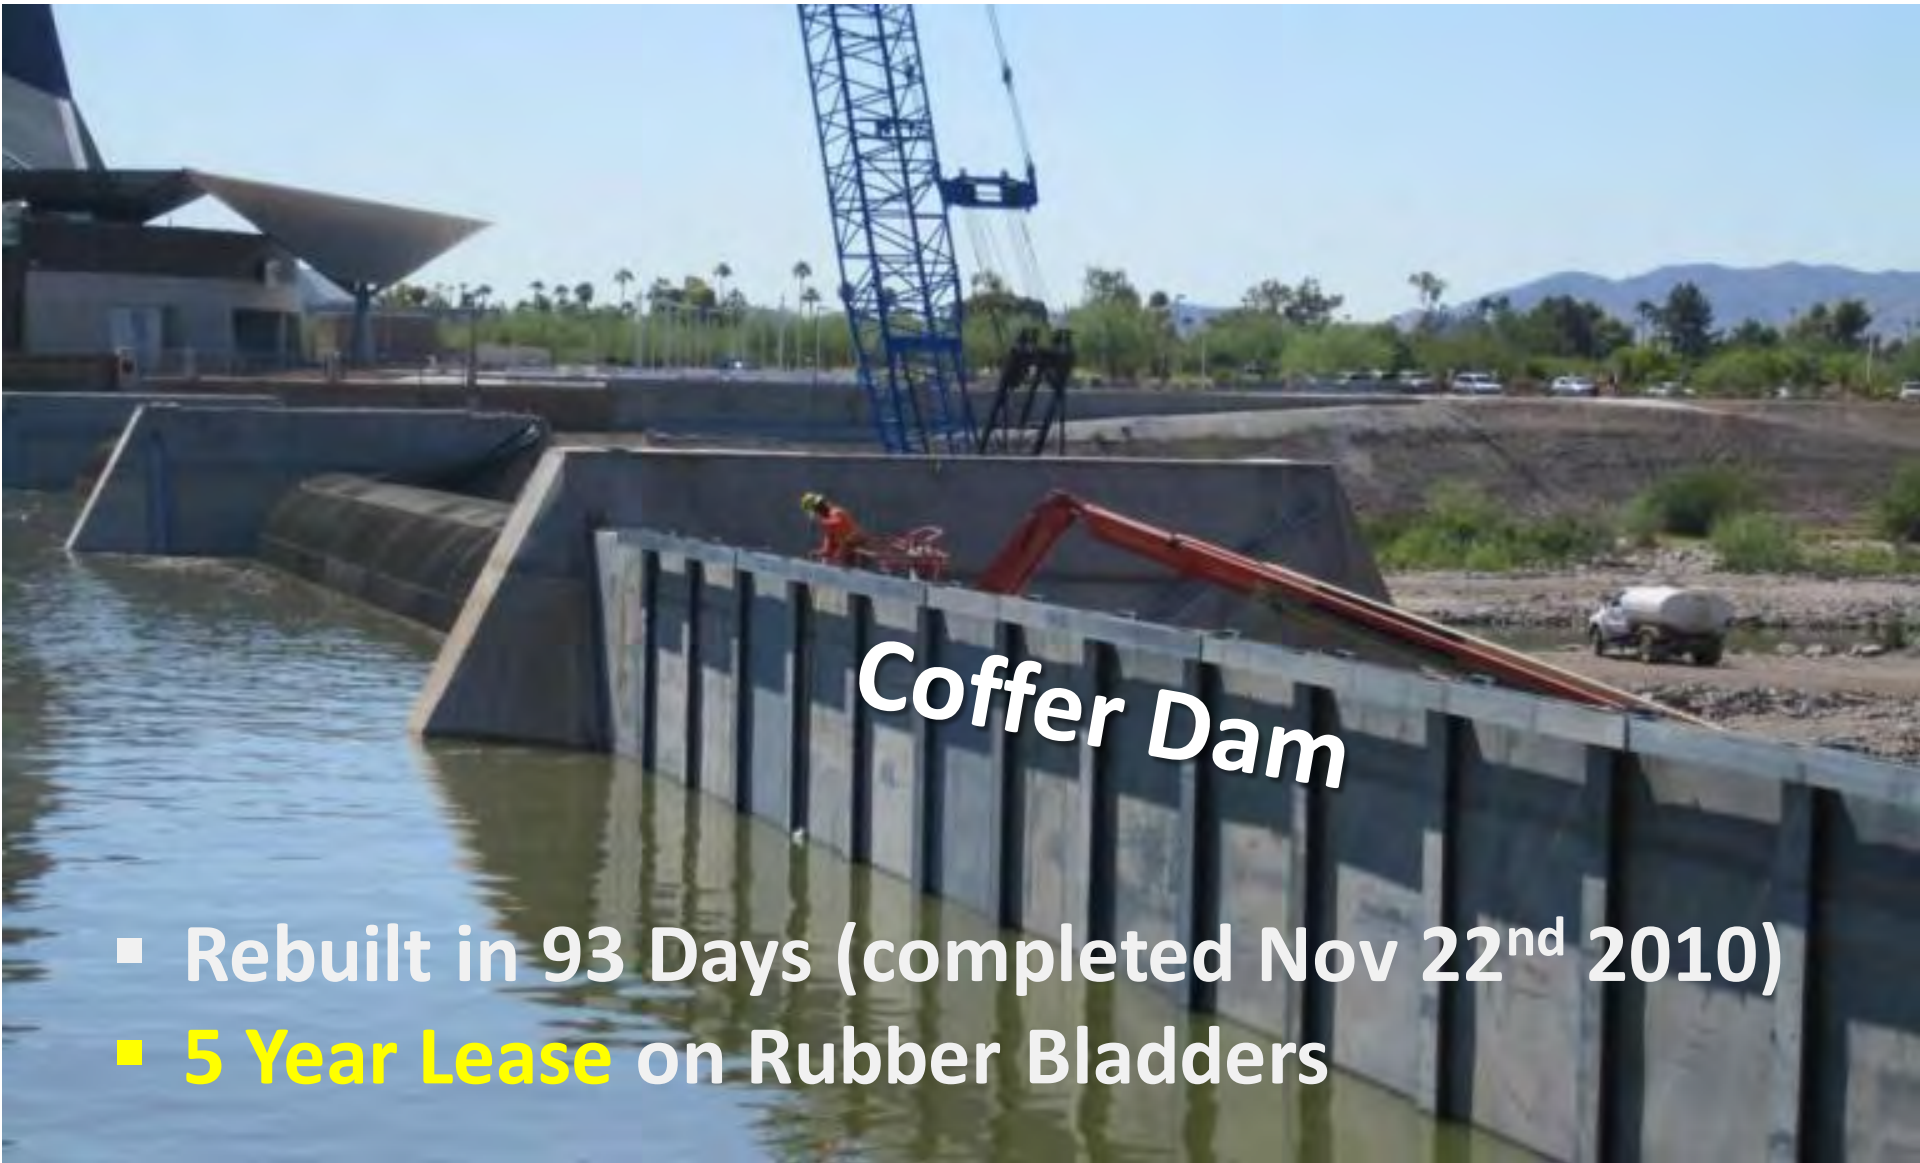
Coffer Dam

- Rebuilt in 93 Days (completed Nov 22nd 2010)
- **5 Year Lease** on Rubber Bladders

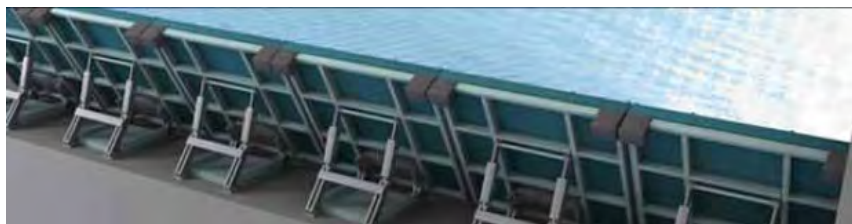
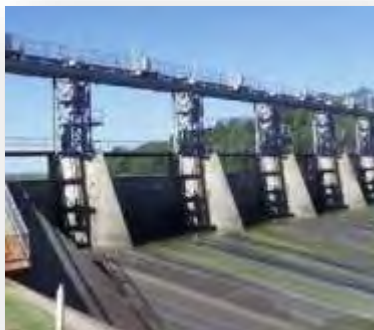
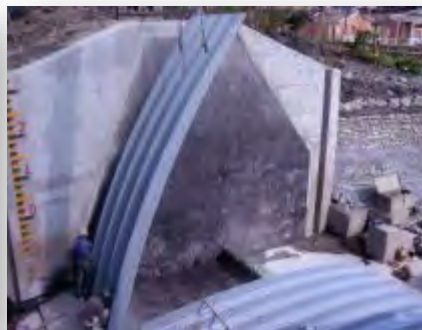
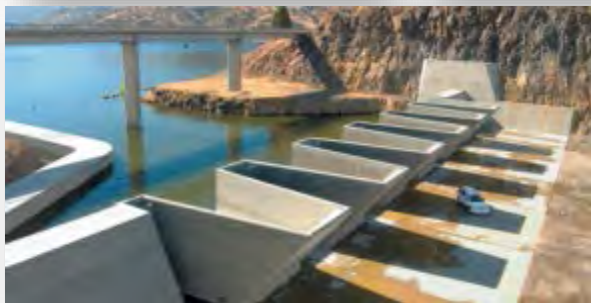
Alternatives Evaluation

About 20 Dam Options Studied:

- Radial (Tainter) Gates
- Bascule or Bottom-Hinged Leaf Gates
- Inflatable Rubber Dams(water and air-filled)
- Ogee Crest Weirs
- Labyrinth Weirs
- Many Styles of Fuse Plugs
- Several Styles of Pneumatically-Operated Hinged Crest Gates (Obermeyer)
- **Hydraulic Hinged Crest Gates**
- Dyrhoff Rubber Dams (Sumitomo)
- Vertical Lift Gates
- Swing Gates
- Fusegates (Hydroplus)
- Earth Embankment/Fuseplug
- Several Styles of Mixed-type Spans
- Cable-Operated Hinged Crest Gate
- Others

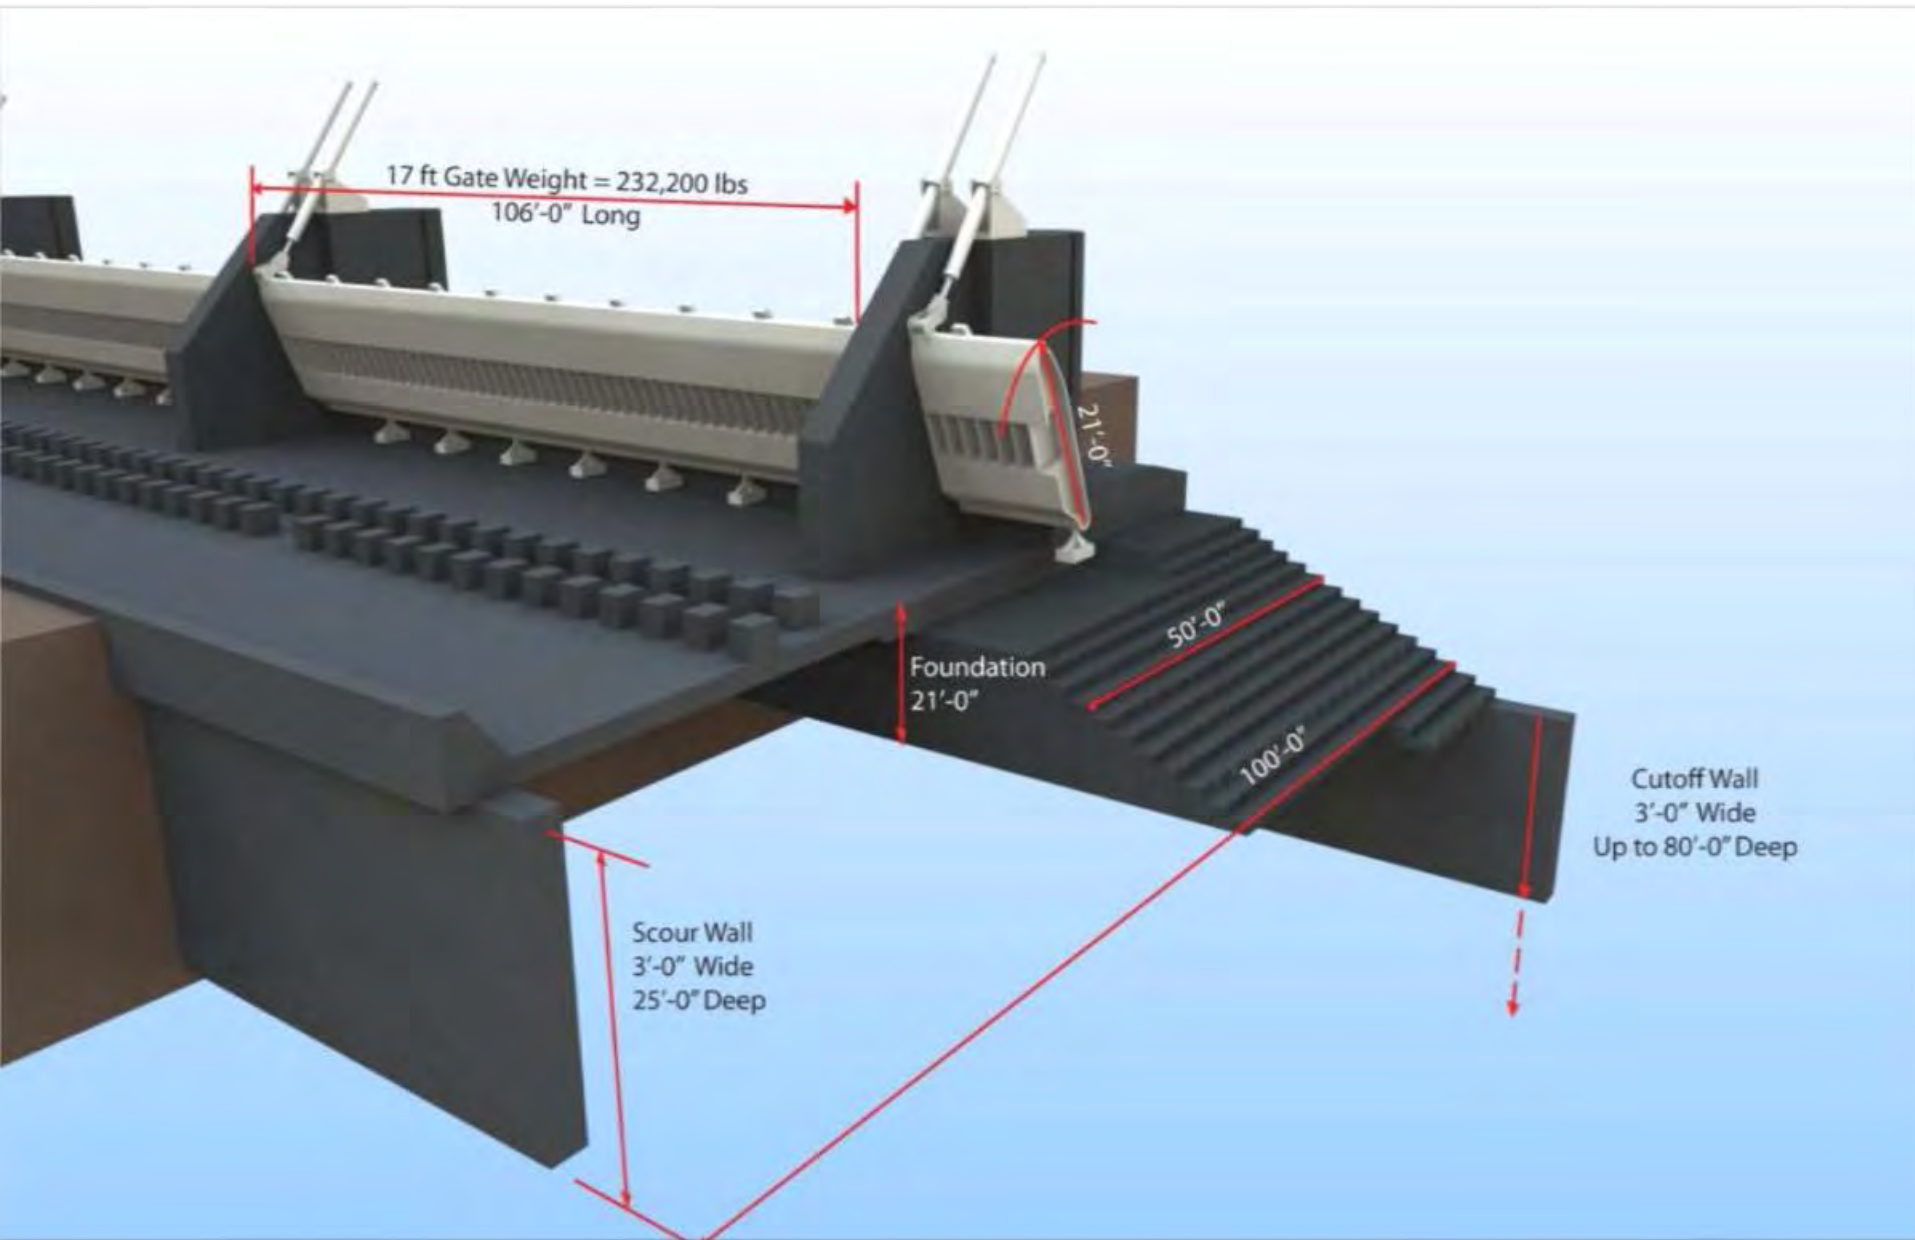
- **Designed to withstand failed scour wall (no passive resistance)**
- **Designed to withstand failed/ineffective cutoff wall along with an ineffective drainage layer (full uplift pressure)**

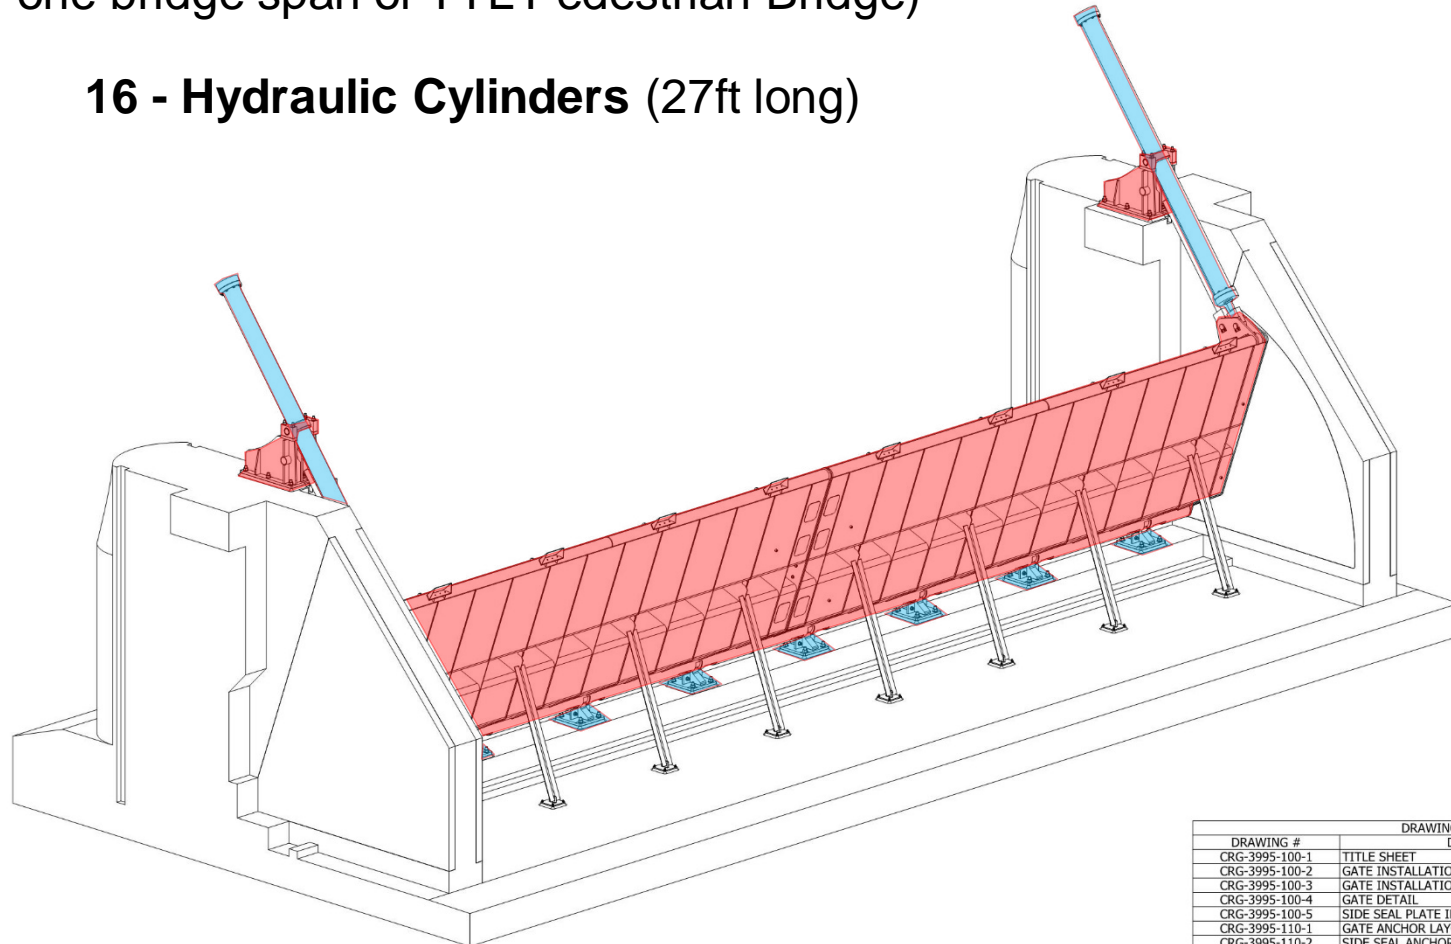
Gate

8 - 106 ft long Steel Gates
(260,000 lb. each equivalent to the weight of
one bridge span of TTL Pedestrian Bridge)

16 - Hydraulic Cylinders (27ft long)

- CLEAR WATER WAY WIDTH: 106.0'
- GATE HEIGHT: 17'

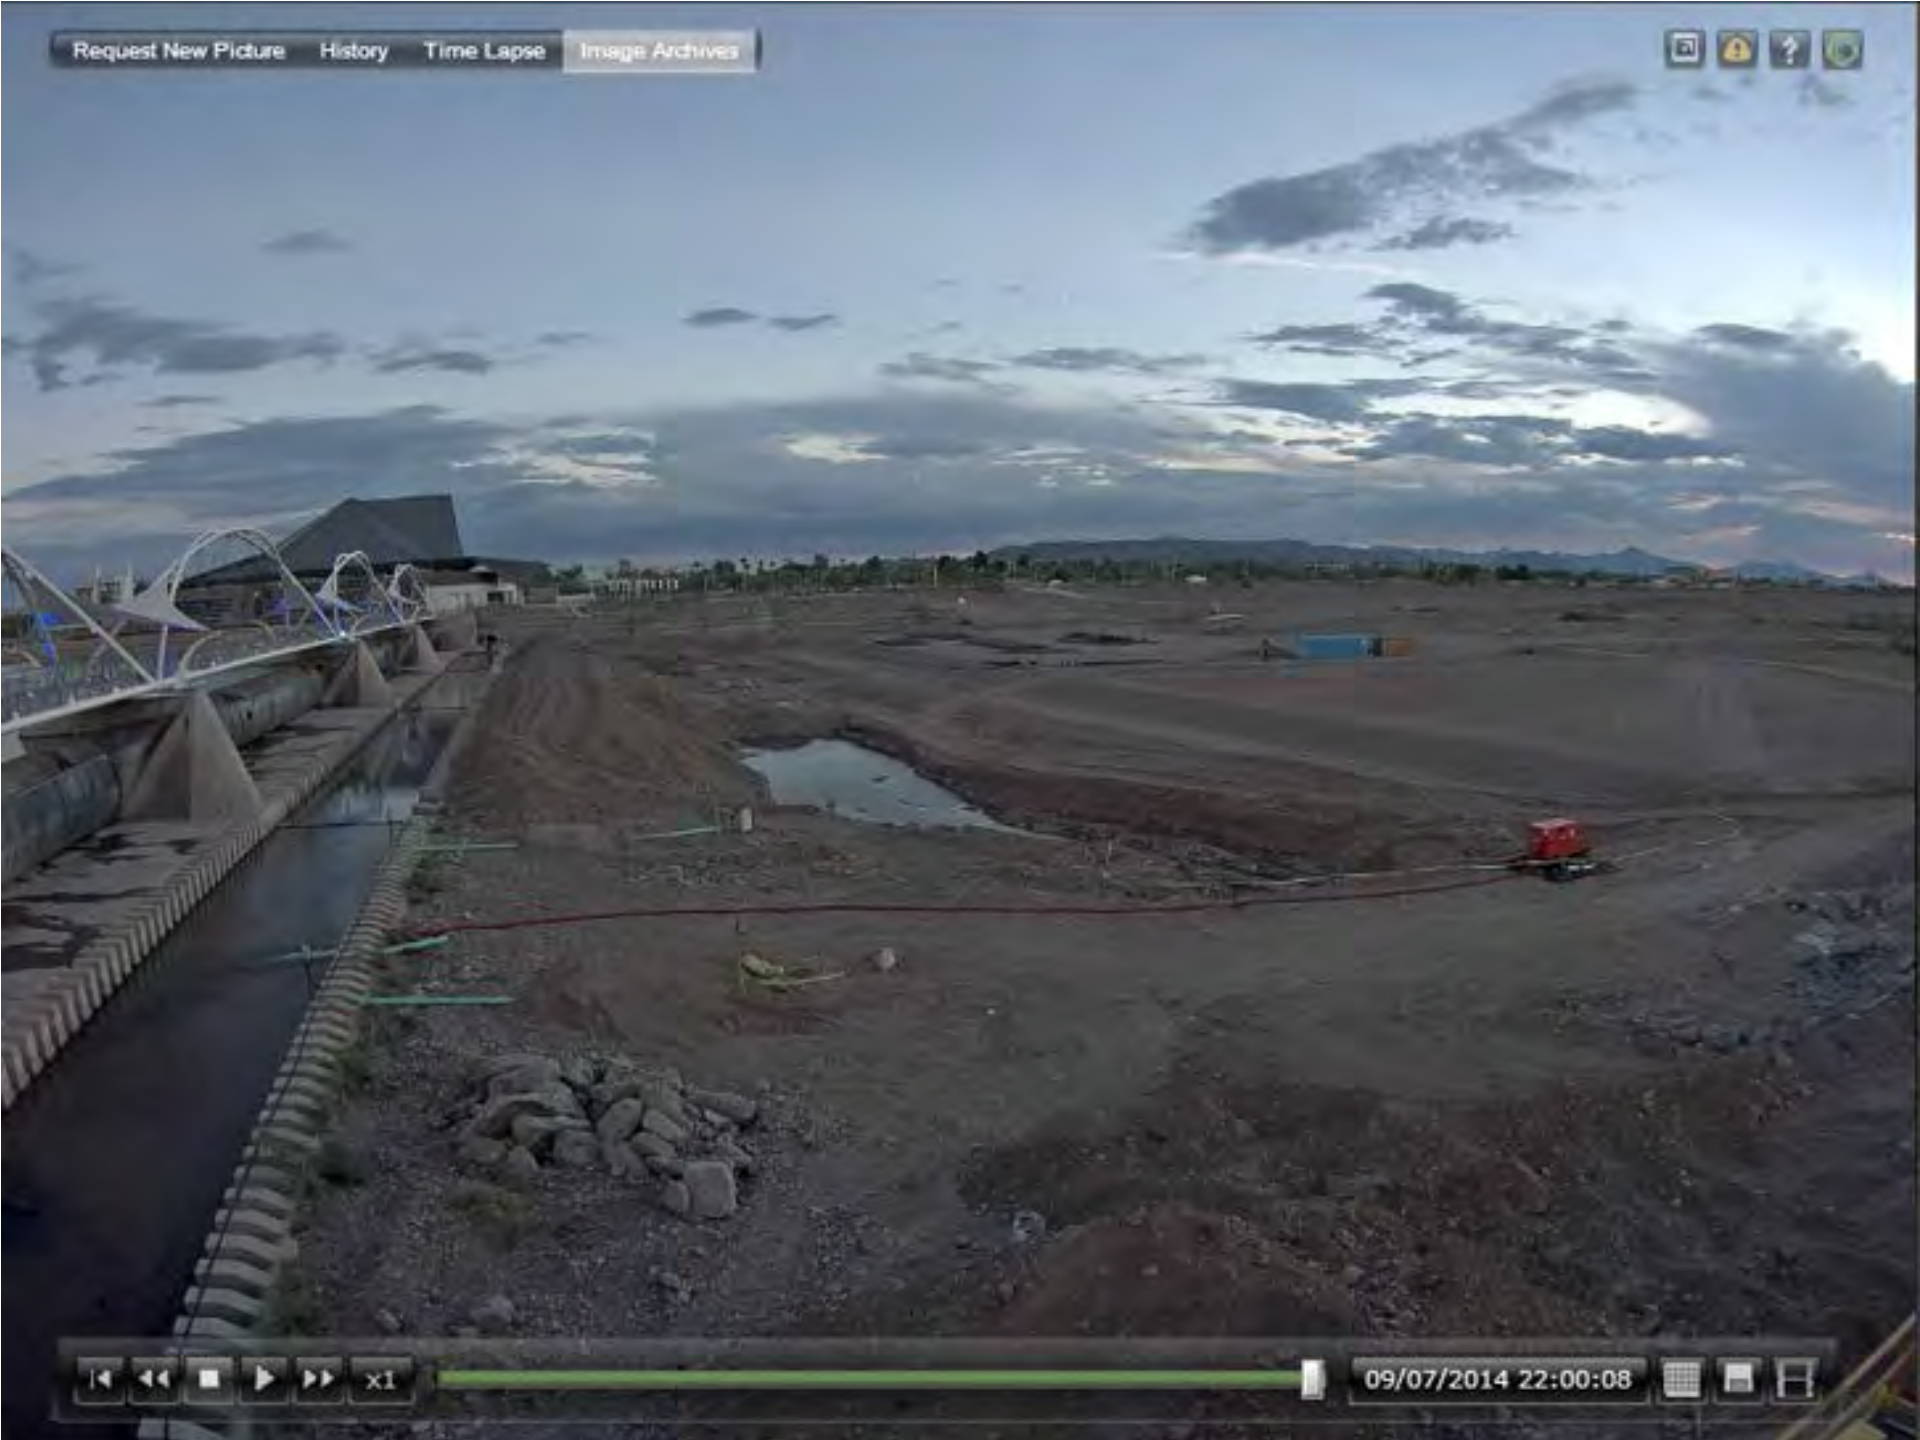
Rebar cages

Peak Flow (8,440 cfs)

Bladders 3 and 4
lowered

Material washout

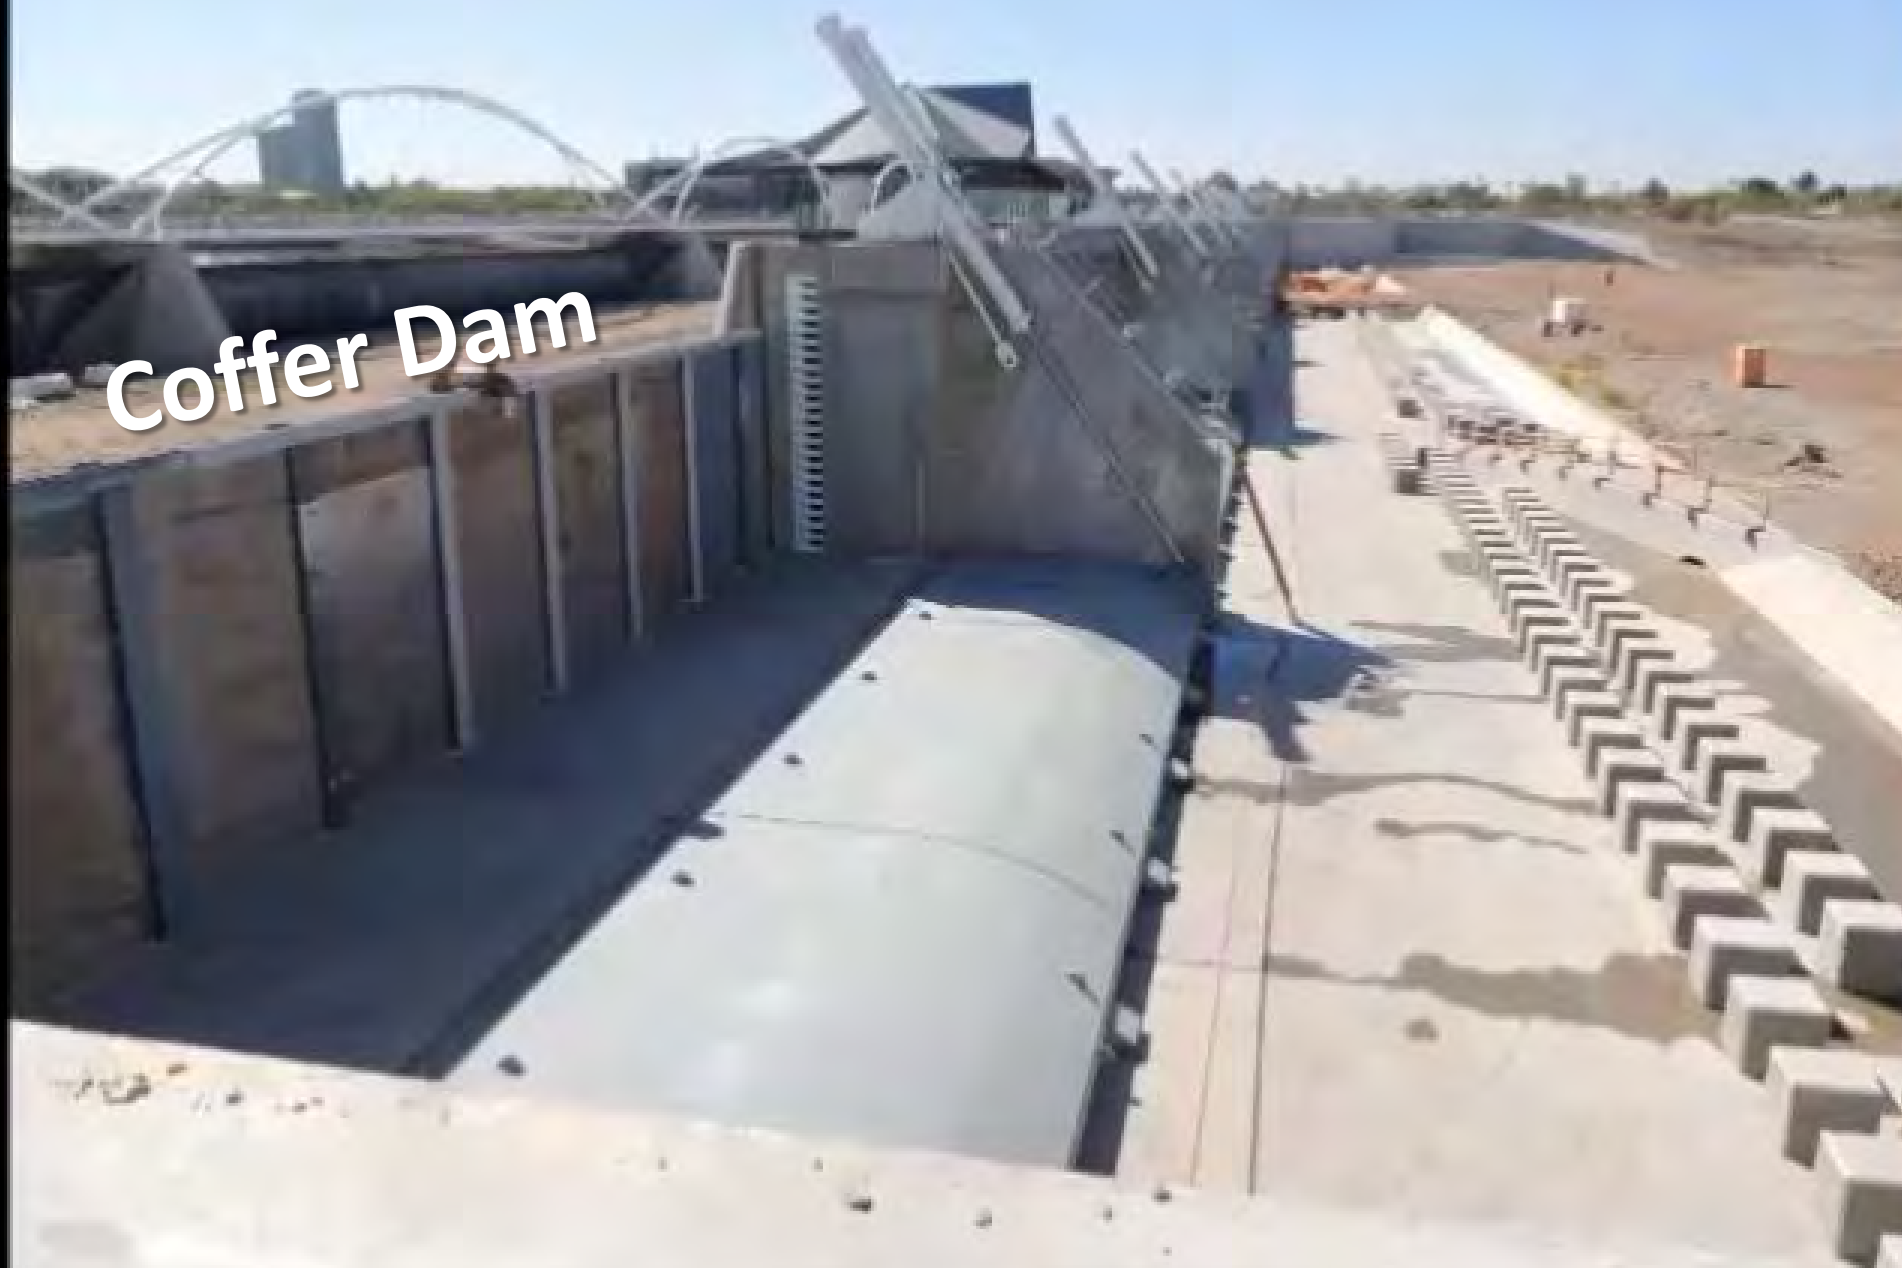
Coffer Dam

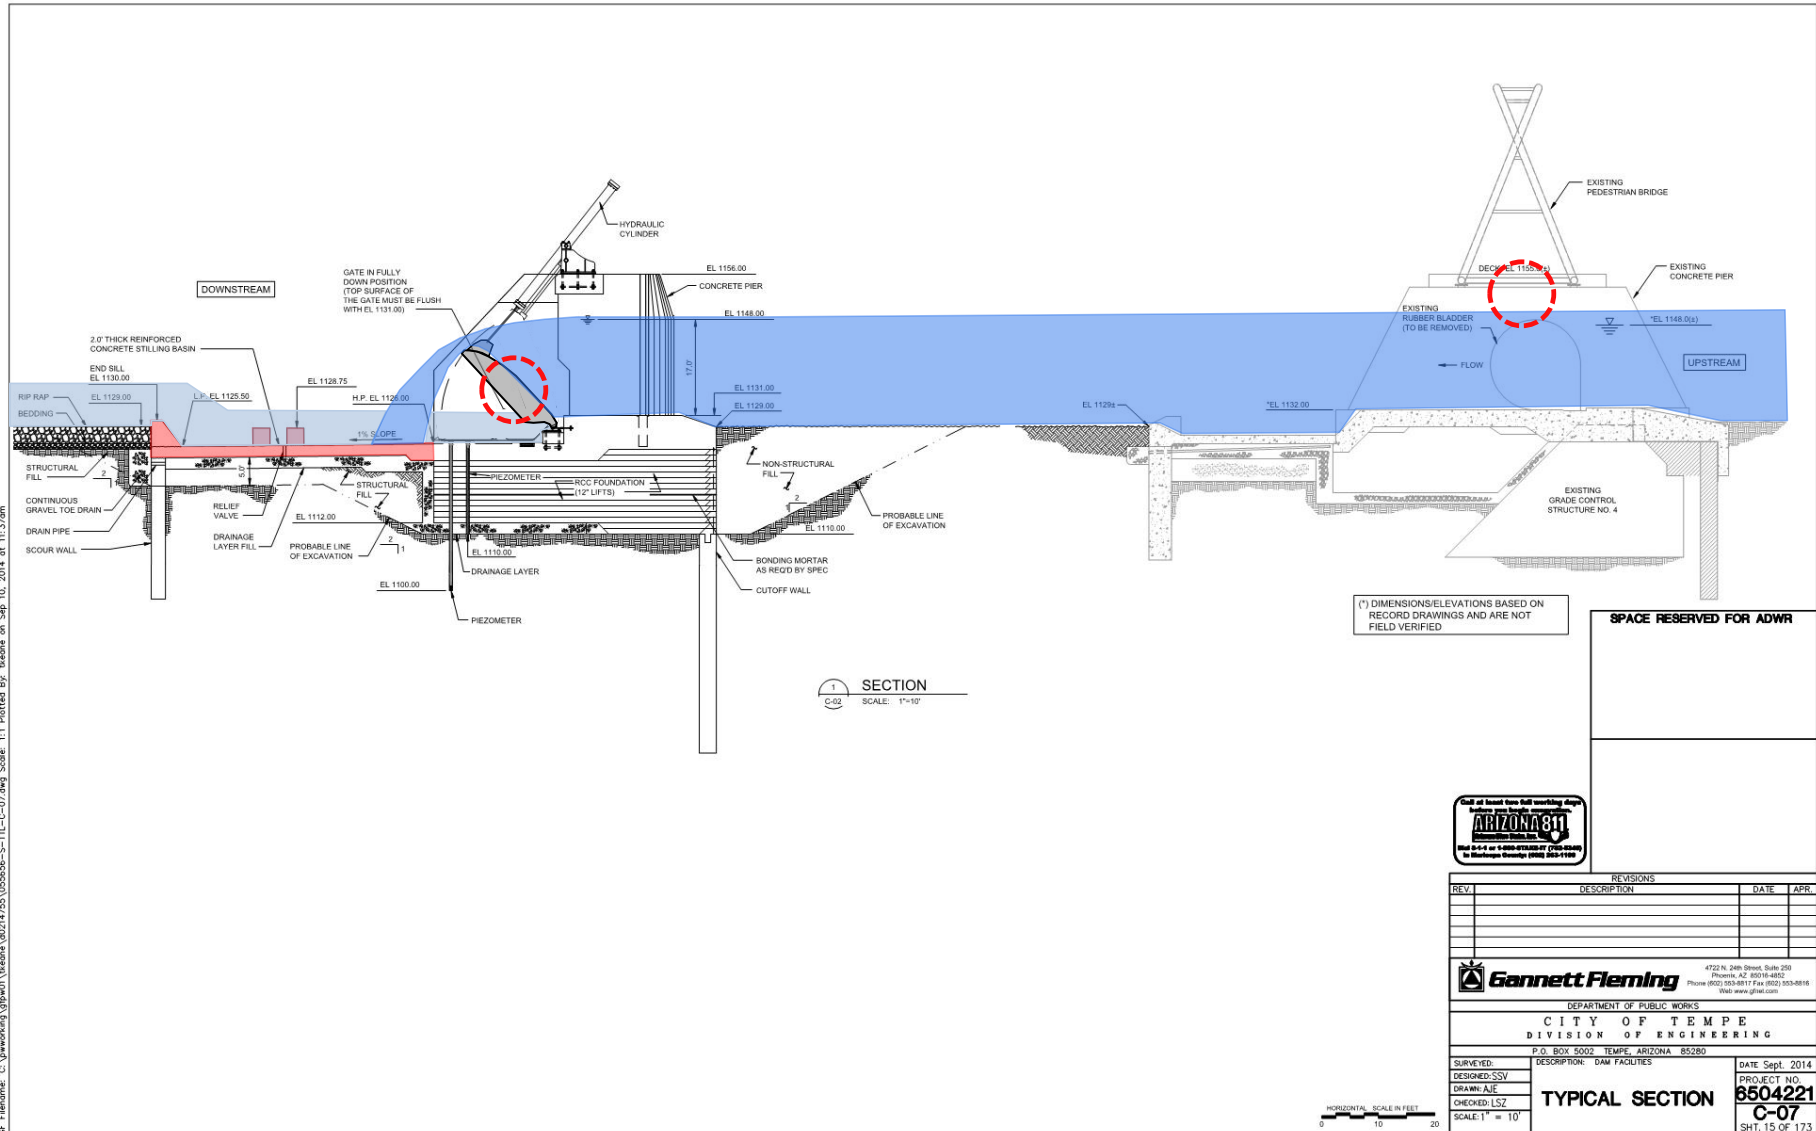
TYPICAL SECTION

(*) DIMENSIONS/ELEVATIONS BASED ON RECORD DRAWINGS AND ARE NOT FIELD VERIFIED

SURVEYED: SSV	DESCRIPTION: DAM FACILITIES	DATE: Sept. 2014
DRAWN: AJE		PROJECT NO: 8504221
CHECKED: LS2		C-07
SCALE: 1" = 10'		SHT. 15 OF 173

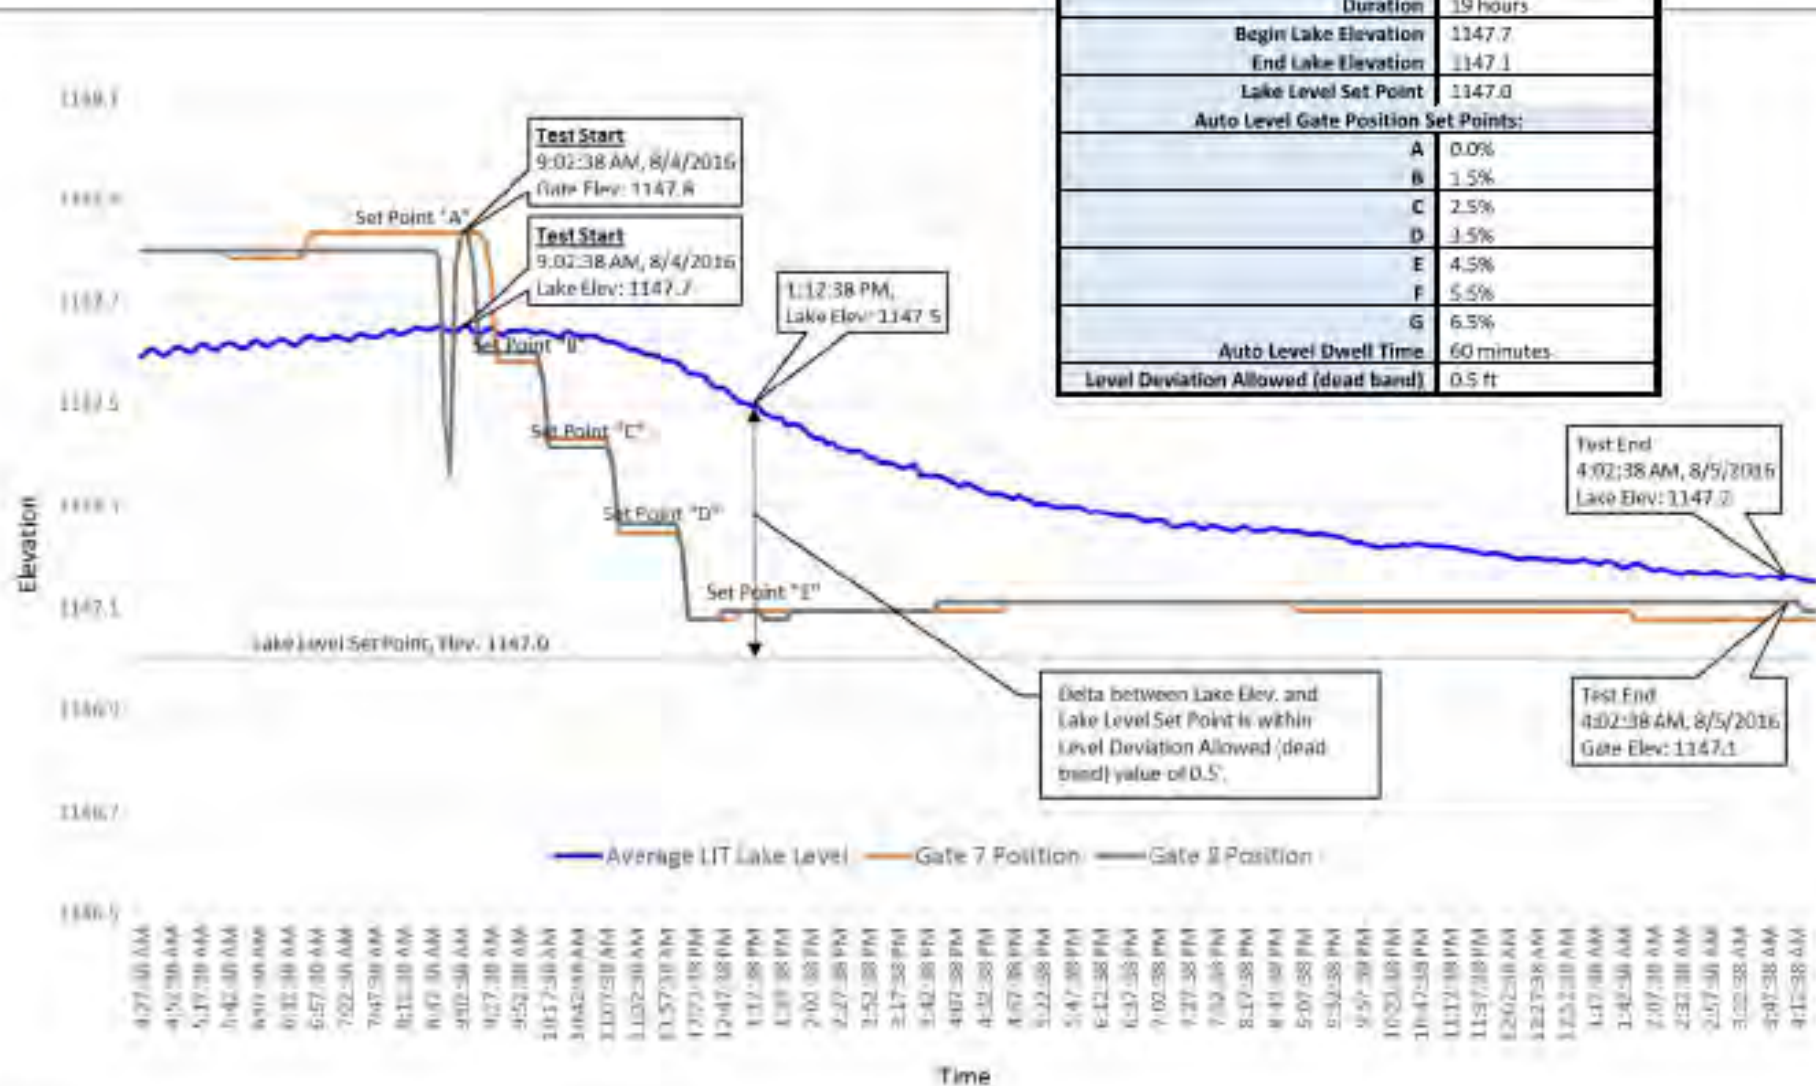
Maintaining Lake Level

Recorded data for Wet Test No. 4b (8/4/2016 and 8/5/2016):

Begin Time	9:00am (8/4/2016)
End Time	4:00am (8/5/2016)
Duration	19 hours
Begin Lake Elevation	1147.7
End Lake Elevation	1147.1
Lake Level Set Point	1147.0
Auto Level Gate Position Set Points:	
A	0.0%
B	1.5%
C	2.5%
D	3.5%
E	4.5%
F	5.5%
G	6.5%
Auto Level Dwell Time	60 minutes
Level Deviation Allowed (dead band)	0.5 ft

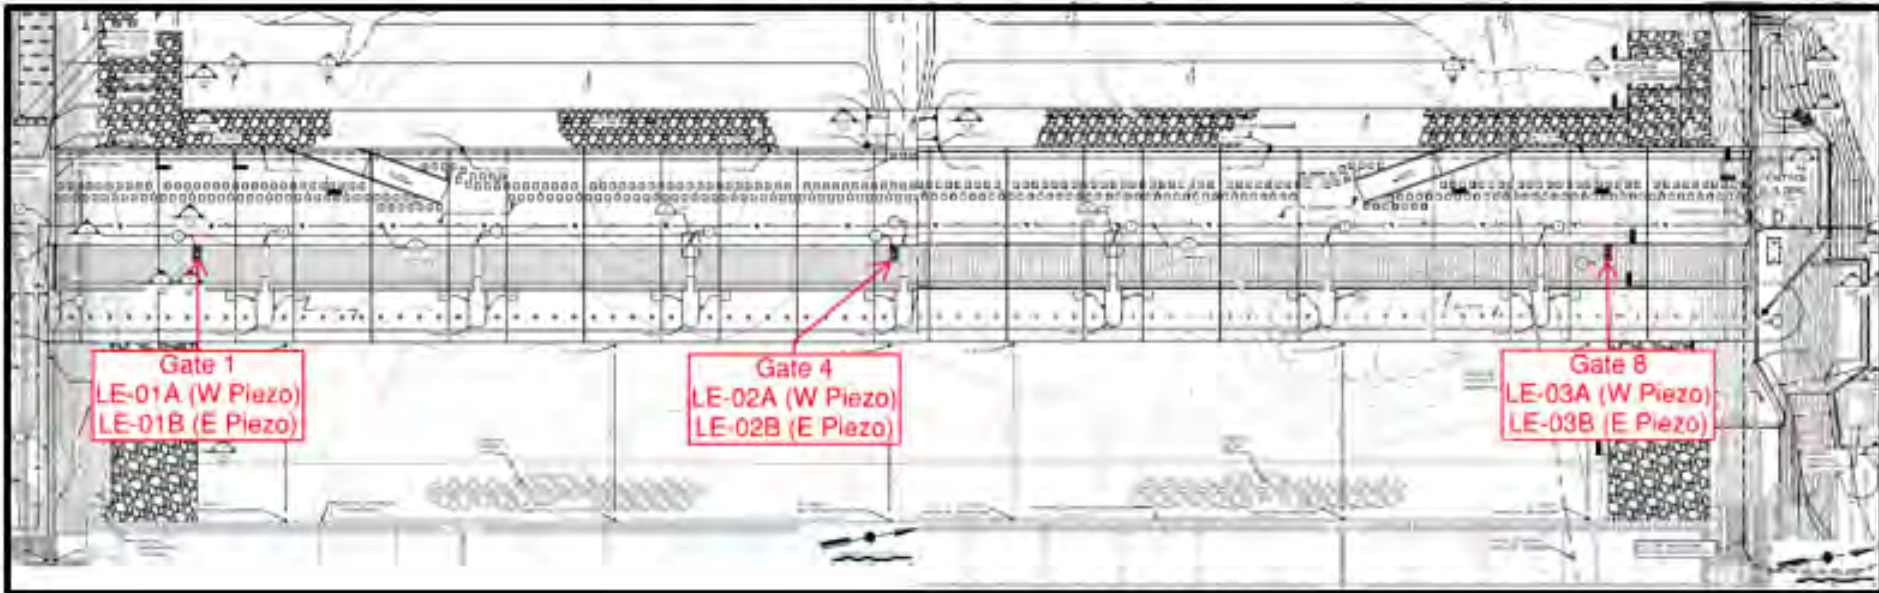
Figure 2 – Piezometer Location Map

Foundation Monitoring
