# **GOLD KING MINE WESTCAS FALL CONFERENCE**

Aaron Chavez  
[achavez@sjwc.org](mailto:achavez@sjwc.org)  
October 28, 2015

# Gold King Mine Spill

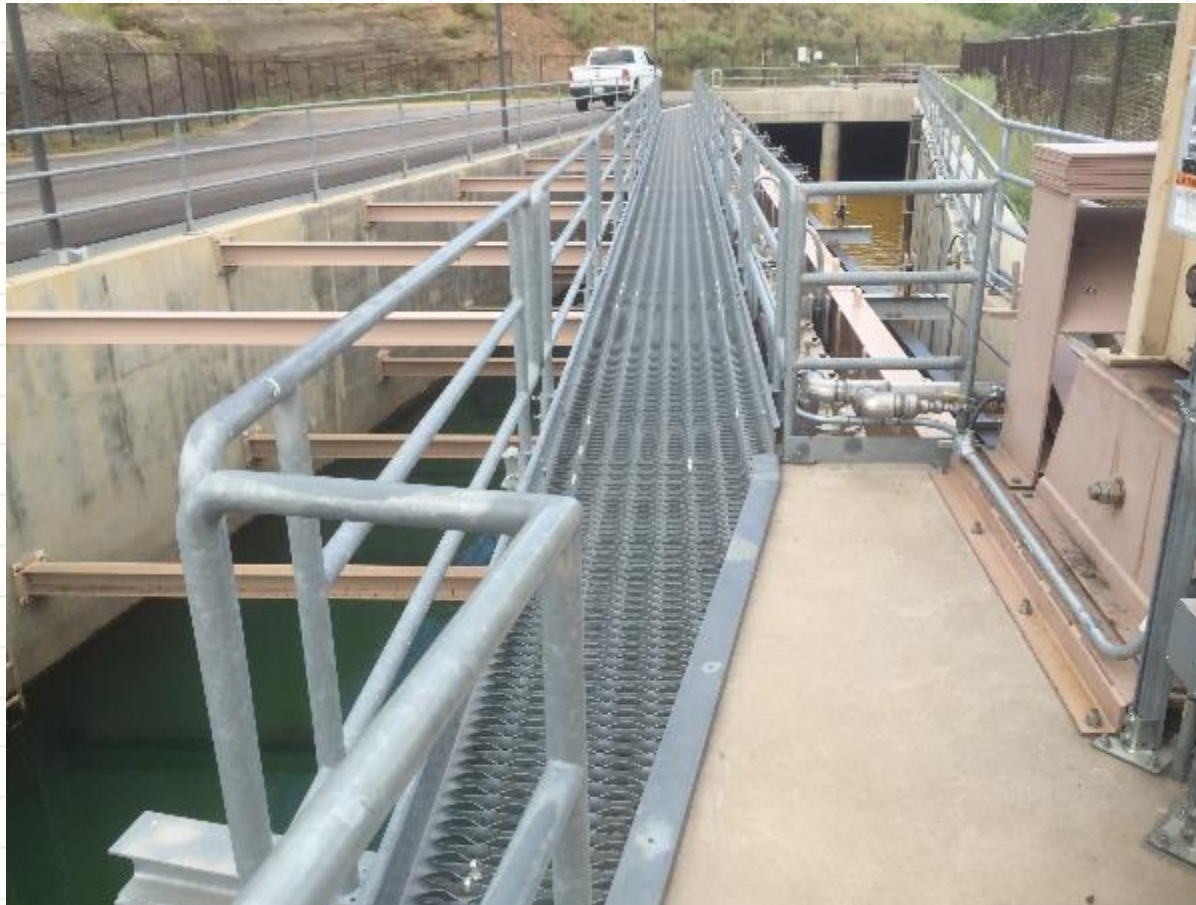
# Animas-La Plata Intake Structure

- Calling Tree activated, Project was notified spill was on the way
- Pumping Plant was not pumping at the time
- Partially isolated the Plant
- Fish Bypass closed and suction valves closed on each pump unit.
- No flow into Pumping Plant and not enough time to install bulk heads into diversion structure.

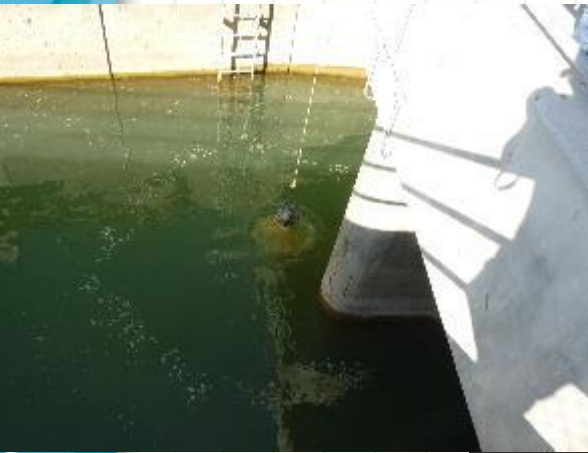
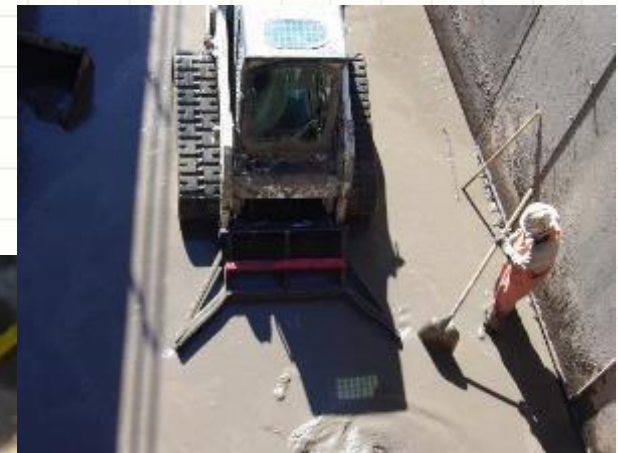
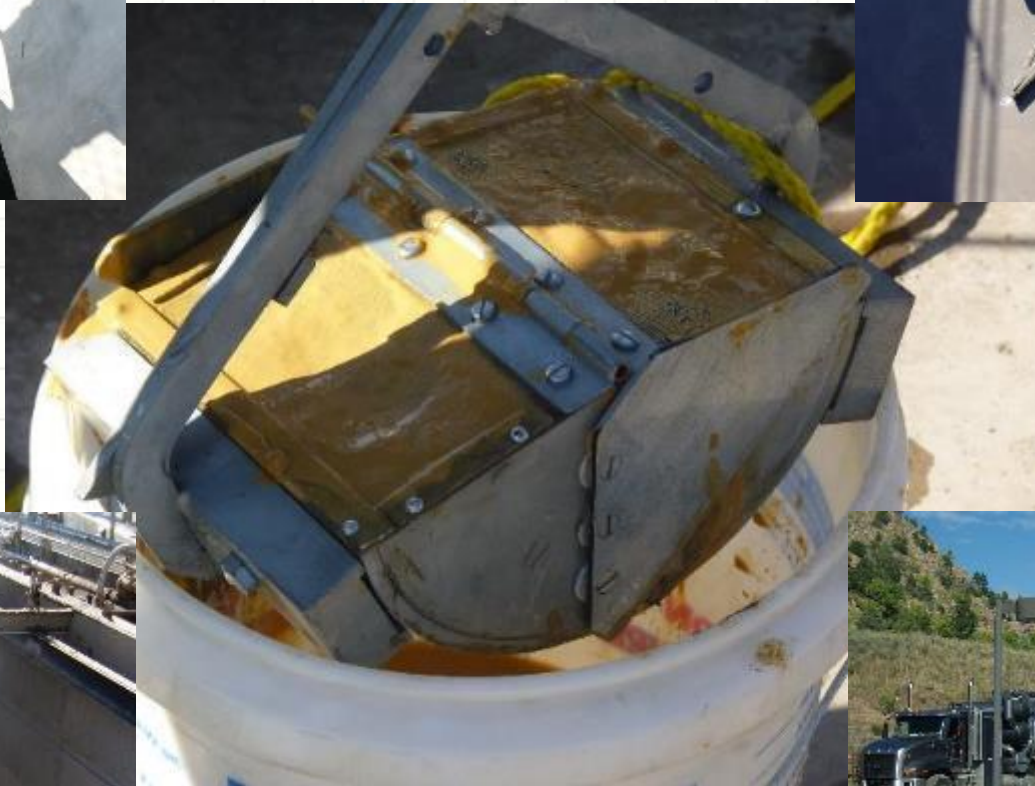
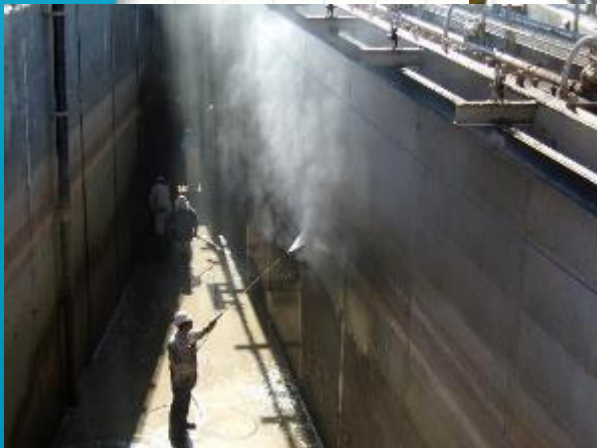
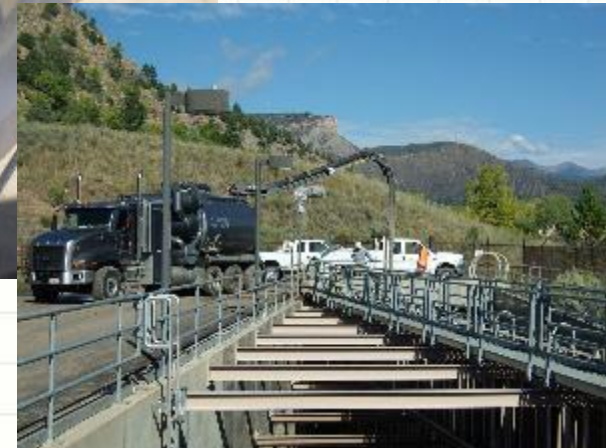
# Animas- La Plata Project Post GKM

- No real impacts to the Project.
- Offsite reservoir; water quality was not affected.
- EPA sampling was an extra step in cleaning the Pumping Plant.
- Sediment will be stored on site and will dry 6-8 months and will be retested and properly dispose of.
- The Animas-La Plata Operation, Maintenance and Replacement Association will not pump next year.
